Damage assessment after the eruption of Mount Usu in 2000

Abstract

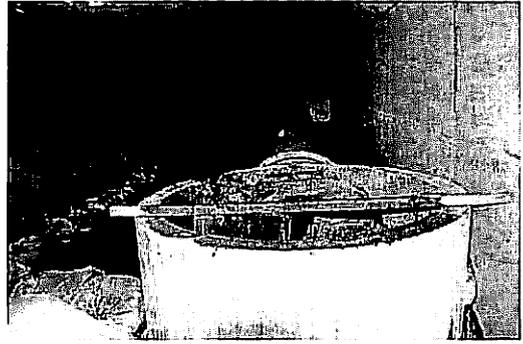
Photo 2 : Damage to the main sewerage line due to the movement of magma underneath

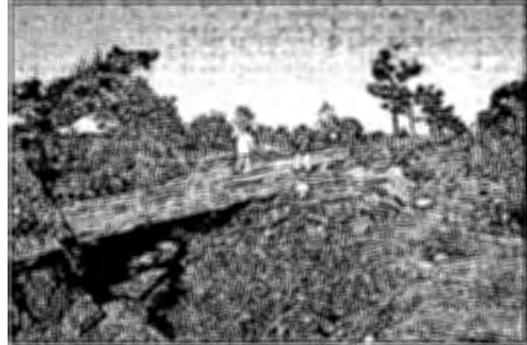
Due to the movement of magma underneath, searching the weak place for eruption, the highway passing through Toyoko day care center had been highly undulated and faulted (Photo 4). The side drains and road pavements had been depressed whereas culverts have been uplifted. Many faults had been formed across the road. The day care center had been totally damaged by the dropped eruption materials that could be observed around the whole school compound (Photo 5). The structures had been tilted and thick volcanic ash accumulation could be observed on the roof of the school. Due to uplifting of the ground, two factories had been totally collapsed (Photo 6) and remaining buildings around the area had been fully damaged. One building had been fully covered up with erupted materials. As mentioned by Tiwari et al. (2001), many landslide topographies could be observed that had been created due to faults and undulations. The earthquake before volcanic activity had damaged Sankei Hospital. The movement of magma beneath had shank down three storied hospital and only two meters part can be seen now from the ground. Besides, the magma movement underneath had shifted the sidewall of Toyo Lake by 30m towards the lake.

Photo 4 : Landslide topography and heavy deformation along the road near Toyako day care center

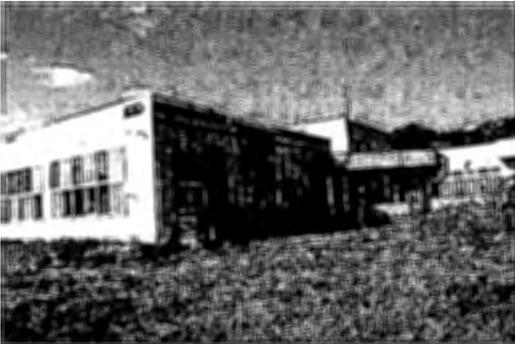
Photo 5 : Damage to Toyako day care center due to the volcanic eruption material

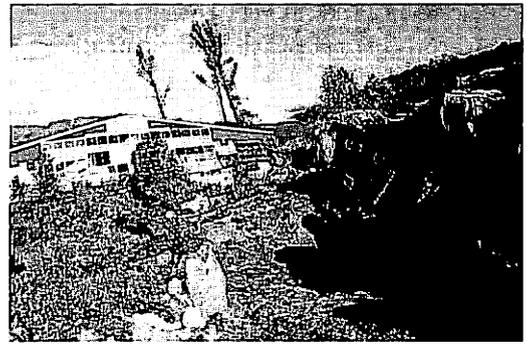
Photo 6 : Damage to the factories due to uplifting of ground by magma movement underneath

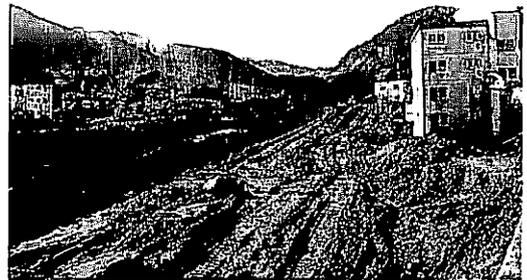
Photo 8 : Accumulated huge amount of debris after the eruption of Kompirayama

The volume of deposited mass near Kompirayama and Nishiyama has been found to be very large. Even after several months of disaster, huge loss has been evidenced. The looseness and continuous accumulation of the deposited debris are potential to slide down after the downpour. The calculation of accumulated debris along the slope and near the crater should be done as far as possible. Moreover, the possible flow route of the deposited mass should be estimated before countermeasure planning. It is utmost to prepare the primary disaster preparedness strategy before the heavy rain.

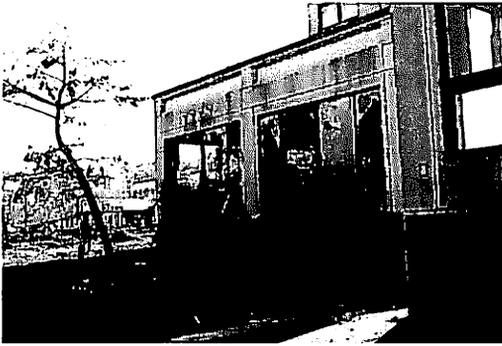
Photo 9 : Damage to the buildings in the housing project due to the deposited debris after eruption

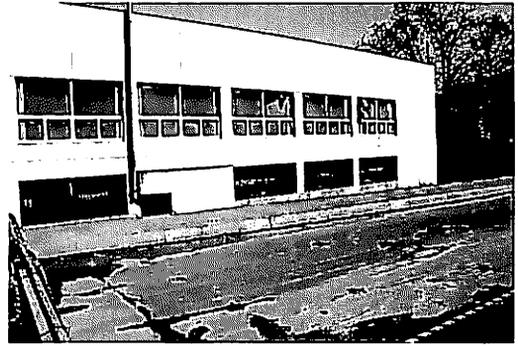
Photo 10 : Damage to the gymnasium by the deposited debris triggered after the eruption

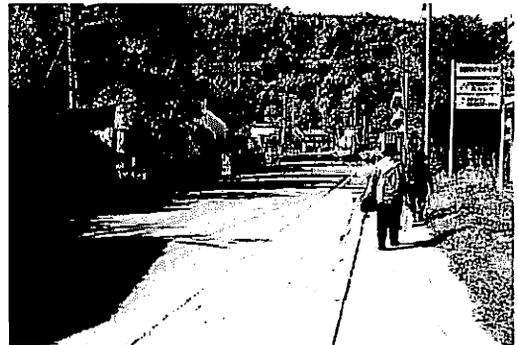
Photo 11 : Deflection in the road after the movement of the ground (can be noticed from the deflected road marking)
