Morphological and Chemical Characterizations of the Interface of a Hydroxyapatite-coated Implant

Key words : Hydroxyapatite-coated implant, Interface, Bonding

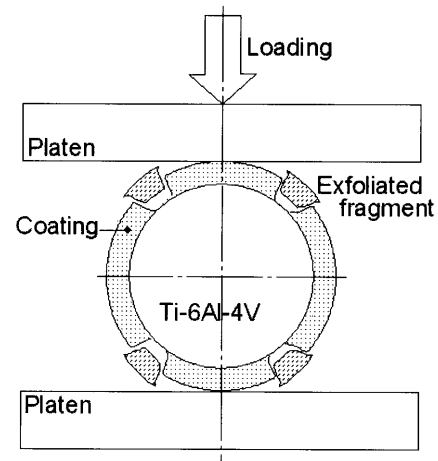
Fig. 1 Diametral loading of transversally cut disk of implant. HA-coating was exfoliated symmetrically at four points near the loading platens.

When a disk is diametrically loaded, low tensile stress tangential to the circumference is induced near the loading points¹⁶⁾, which could cause local exfoliation of the coating layer (Fig. 1). The partial exfoliation of coating layer at these points exhibited a macroscopically cohesive fracture, but the elemental analysis of the surface indicated a mixed mode of interfacial and cohesive fractures at microscopic level (Figs. 3(b), (d)). After the subsequent HCl treatment, low levels of Ca and P were still present at the interfacial fracture surface (Figs. 3(f), (g)) where Ti was previously exposed (Fig. 3(b)). This observation was different from that obtained with the substrate that received HCl-immersion alone, as this treatment left Ca and P all over the substrate surface except for locations where Al_2O_3 particles were detected (Fig. 2). Moreover, the XPS analysis indicated that Ca and P were present mainly in the oxide film on the substrate (Fig. 7).

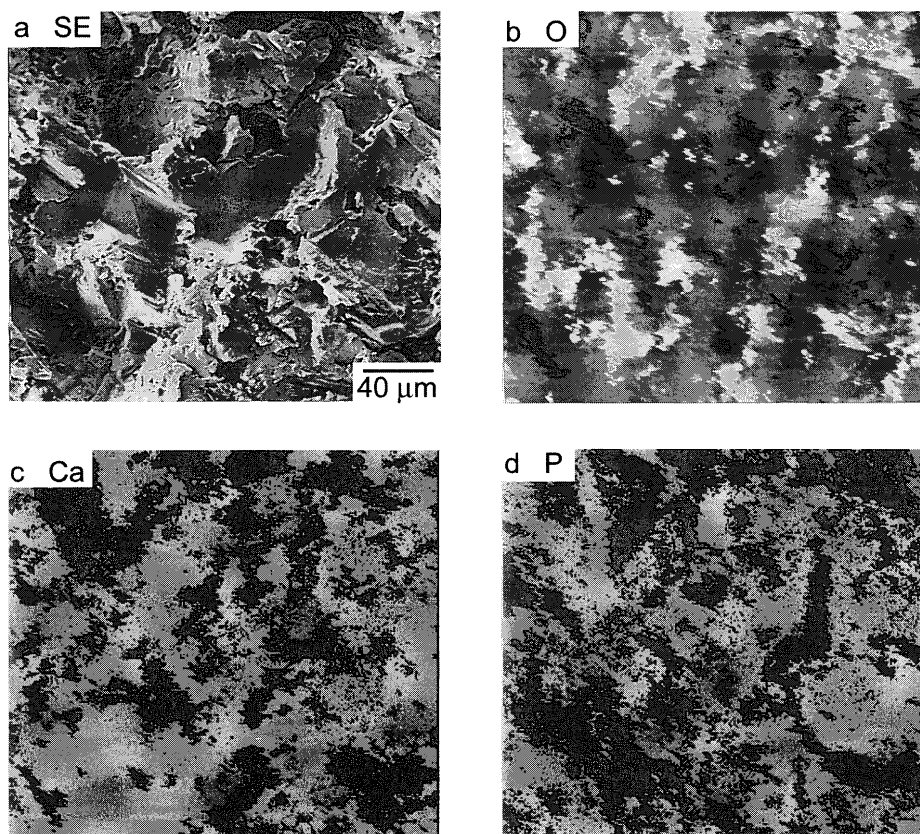
The sample treated with HCl exhibited rough substrate surface (Fig. 2(a)). While the surface showed overall low O content, it also contained areas of high O content (Fig. 2(b)). The former was evidently due to the presence of titanium oxides at the substrate surface. The latter indicated that the substrate alloy had been roughened by Al_2O_3 grit blasting prior to HA spraying, as Al also coexisted in these areas (not shown). The substrate surface also showed overall low Ca and P distributions, except for the locations where Al_2O_3 particles remained (Figs. 2(c), (d)). No exact correlation was found between the Ca and P maps. This might be partly caused by surface unevenness: the directions normal to the depression slopes were different from point to point with respect

Fig. 2 Results of EPMA conducted on substrate surface exposed by HCl-dissolution of HA-coating. The element distribution maps are displayed with respective five-level gray scales.

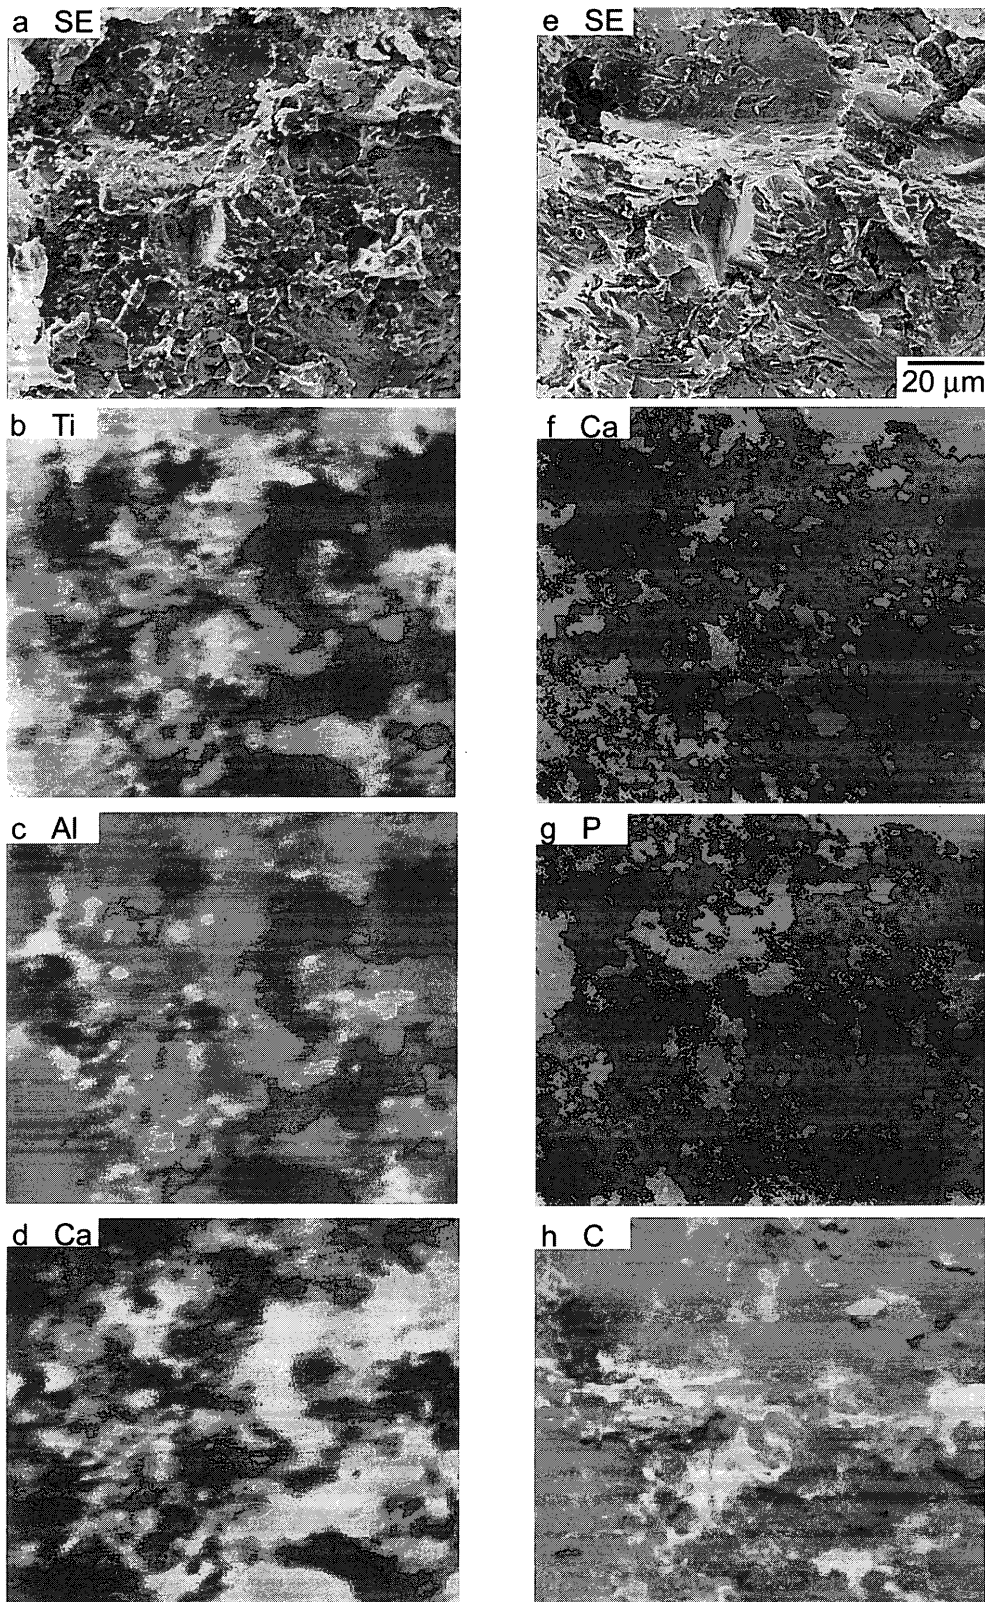
Fig. 3(a) shows the substrate surface that was mechanically exposed by diametral compression. The surface was characterized by differences in Al content: little, low, or high (Fig. 3(c)). Mapping of Ti (Fig. 3(b)) confirmed that the low Al content areas represented the substrate alloy and the high Al content areas were the embedded Al_2O_3 particles. The distributions of Ca (Fig. 3(d)) and P (not shown) were in reverse proportion to that of Ti, indicating the presence of remaining coating fragments. The mechanically exposed surface appeared relatively even in comparison with the chemically exposed surface (Fig. 2(a)), as concavities present on the substrate surface were filled with remaining coating fragments. This was confirmed as the surface irregularities became more distinct after the sample received additional acid treatment (Fig. 3(e)). The acid treatment also revealed that Ca (Fig. 3(f)), though in very low content, was detected in the previously exfoliated areas rather than in the areas where remaining coating fragments were found. A similar finding was confirmed in P (Fig. 3(g)). Again, no distinct correlation was found between the maps of Ca and P. Carbon was unevenly distributed throughout the

substrate surface, and its contents were very high in the previously exfoliated areas (Fig. 3(h)).

Fig. 3 Results of EPMA conducted on substrate surface.

(a)-(d) Surface exposed by diametral loading.

(e)-(g) Re-analysis of the same area after additional treatment with HCl solution. The element distribution maps are displayed with respective five-level gray scales.

Diametral loading exfoliated the coating from this film at places where the bond was weak (interfacial fracture on the right side of Fig. 8(c)). Since the oxide film remained attached to the substrate (right side of Fig. 8(d)), Ca and P in low contents could be detected in the interfacial fracture area (Figs. 3(b), (f), and (g)). On the other hand, at places where the coating was strongly bonded to the oxide film, the loading exfoliated the coating together with the film from the underlying substrate (cohesive fracture on the left side of Fig. 8(c)). Simultaneously, the coating fractured cohesively into fragments but many fragments remained mechanically held in concavities present in the substrate. During the HCl treatment after loading, the oxide film which was attached to the exfoliated fragments, while highly acid-resistant, was lost along with the dissolution of the fragments (left side of Fig. 8(d)). Ca and P were thus hardly detected in the substrate beneath the remaining fragments (Figs. 3(d), (f), and (g)).

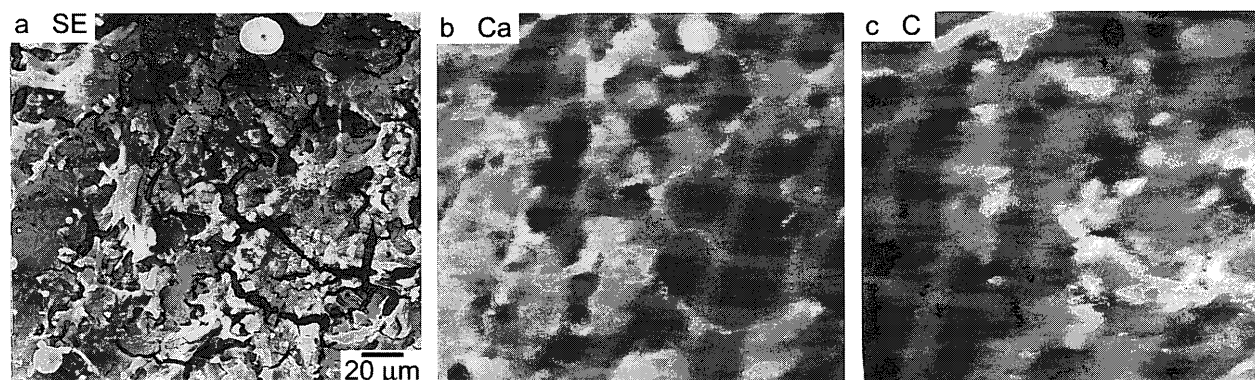
Fig. 4(a) shows the coating that adhered to the masking tape. Apart from heavy cracking due to the hammering, the observed surface was relatively even, again indicating that fragments of coating material were held in concavities present on the substrate surface.

The oval-shape halation shown at the top of Fig. 4(a) demonstrates high Ca, P, and O contents (P and O maps not shown). It was found that similar round particles were formed in the area, which had been subjected to element analysis (Fig. 5).

Unexpectedly, Ca-deficient areas were found (Fig. 4(b)). Similar observations were confirmed for P and O (not shown). These Ca-, P-, and O-deficient areas were very rich in C (Fig. 4(c)). However, high concentration of C was not found in the exterior surface of the coating.

Fig. 4 Results of EPMA conducted on substrate-side surface of HA-coating fragment. The fragment was obtained by hammering the implant disk at the center. The element distribution maps are displayed with respective five-level gray scales.

High C content areas were present in the interior (substrate-side) surface of coating fragment (Fig. 4) but not on the exterior surface. Carbon also concentrated in the interfacial fracture areas on the substrate of the diametrically-loaded specimen (Figs. 3(b), (h)). However, it was difficult to identify the C-rich phase by EPMA. Moreover, C was widely distributed in the depth direction (Fig. 7(c)). The TiC-like phase might be formed by reaction between substrate and C during spraying. Since the details of plasma-spraying technique are proprietary to manufacturer, it is unknown whether the incorporation of C is intentional or not. It may be assumed that the carbon originated from hydrocarbons which had been present on the substrate before spraying. However, this hypothesis alone fails to account for the high C content indicated by EPMA. Further investigation is therefore needed to understand the influence of C on the bond strength between coating and substrate.

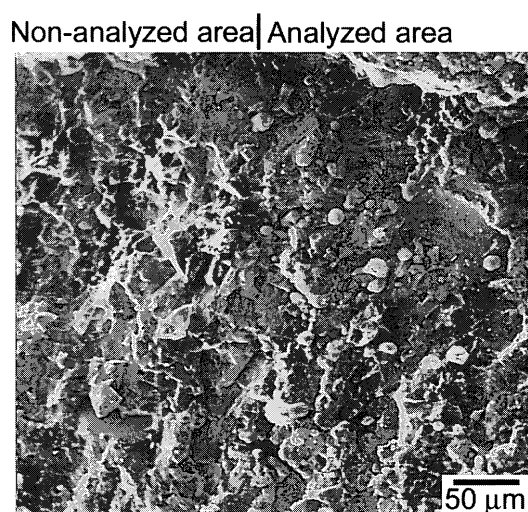
Fig. 5 Morphological change of substrate-side surface of HA-coating during EPMA. SE images before and after EPMA are shown on left and right sides, respectively.

A number of round particles with high contents of Ca, P, and O were observed on the substrate-side surface of coating that had been subjected to element analysis (Figs. 4 and 5). During element analysis, temperature of the sample with lower heat conductivity was raised more substantially. Therefore, calcium phosphates with low melting points melted due to the heat and then solidified subsequently. It is

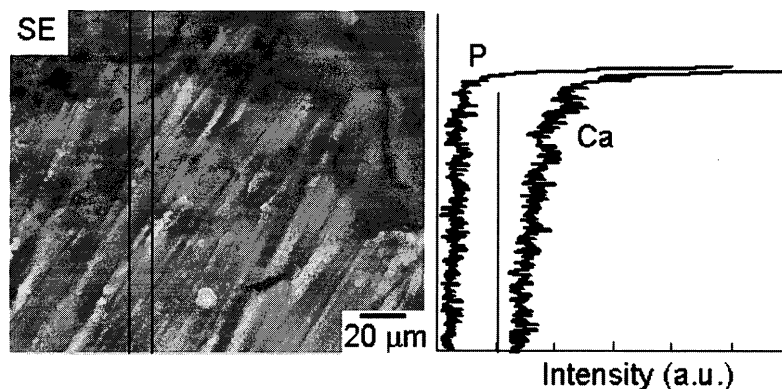
Fig. 6(a) shows an SE image of the vicinity close to the boundary between coating and metal substrate.

The latter is identified by abrasive-induced scratches and Al_2O_3 particles are observed as dark spots. For representative demonstration of Ca and P distributions around the boundary, averaged $\text{CaK}\alpha$ and $\text{PK}\alpha$ intensities in the area between the two parallel lines are shown as line profiles in Fig. 6(b). The Ca content decreased gradually from the boundary within a depth of up to 5 to 10 μm , while the P content decreased rapidly to the background level at the boundary. The difference indicated a higher diffusion of Ca than P into the metal substrate.

Fig. 6 Ca and P distributions from HA-coating to substrate. Line profiles of $\text{CaK}\alpha$ and $\text{PK}\alpha$ intensity are shown as average in area between parallel lines.

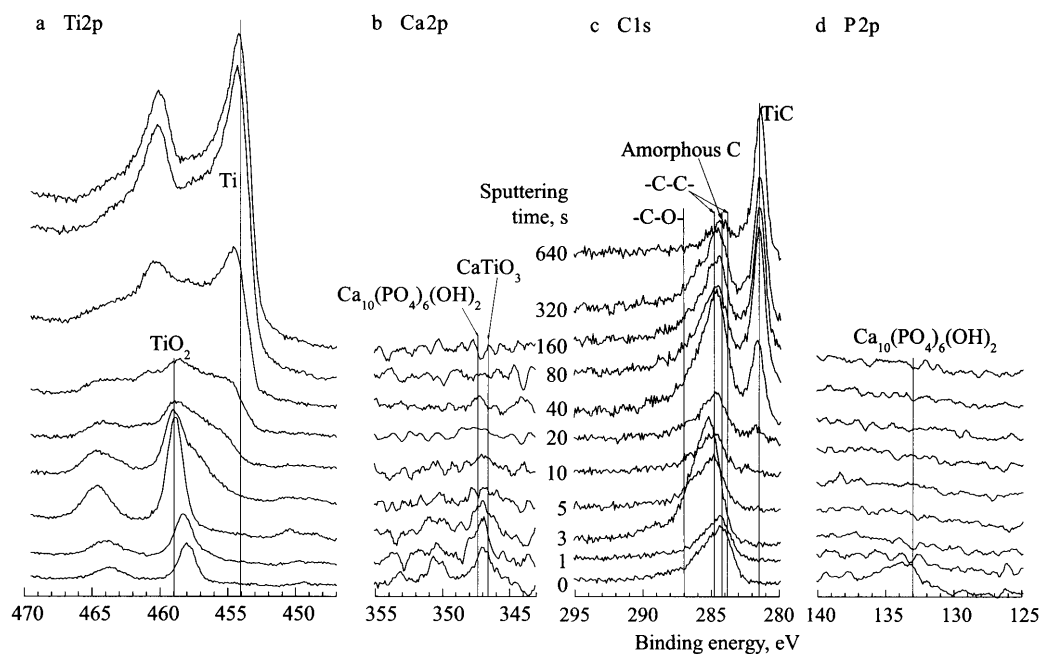
Fig. 7 shows the XPS analysis results. Peaks of Ti $2p_{3/2}$ were assigned to TiO_2 and then metallic Ti, as the analysis shifted deeper into the substrate. The oxide film was of nanometer order in thickness. In

one sample, weak peaks of Ca $2p_{3/2}$ and P $2p$ were found at the outermost surface (Figs. 7(b), (d)). In another sample, only P $2p$ peak was found (not shown). Comparison of the Ca $2p$, P $2p$, and Ti $2p$ depth profiles suggested the presence of Ca and P in the oxide film. The XPS analysis did not detect any metallic Ca diffused into the metal substrate, probably due to its low content. C $1s$ peaks first appeared at higher energies and then at a lower energy (Fig. 7(c)). The latter peak might be assigned to TiC.

Fig. 7 Results of XPS conducted on substrate surface immersed in HCl solution: Ti (a), Ca (b), C (c), and P (d).

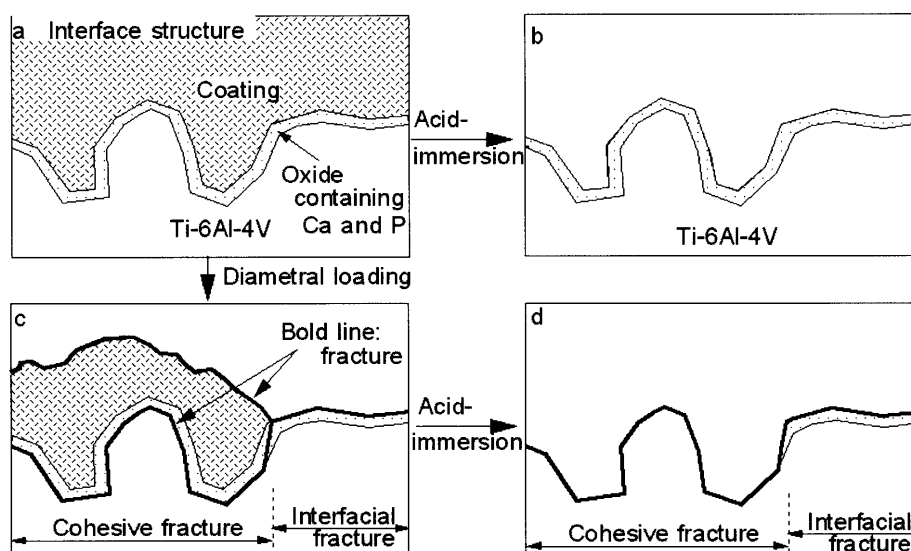
Fig. 8 Postulated interface structure model and fracture mode. The thickness of oxide film is exaggerated. Alumina particles are omitted here.

Based on the present results, it is possible to postulate an interfacial fracture model for HA-coated Ti or Ti alloy implants (Fig. 8). A thin titanium oxide film containing Ca and P was present at the interface (Figs. 8(a), (b)), as Ca and P in low contents were widely detected in the substrate surface exposed by the simple HCl treatment (Figs. 2(c), (d)). This was further confirmed in the comparison made between the depth profile of Ti $2p$ with those of Ca $2p$ and P $2p$ (Figs. 7(a), (b), and (d)).

results indicated, however, that the fractures at both the interfaces between the coating and oxide film and between the alloy and oxide film occurred as interfacial and cohesive fractures, respectively. In other words, the mechanical interlocking action due to surface irregularities is still the major factor which determines bond integrity.
