## Sliding Mechanism of Okimi Landslide and Analysis of Overall Blocks

Binod TIWARI and Hideaki MARUI

Keywords : landslide, investigation, prevention, residual shear strength, stability analysis, factor of safety.

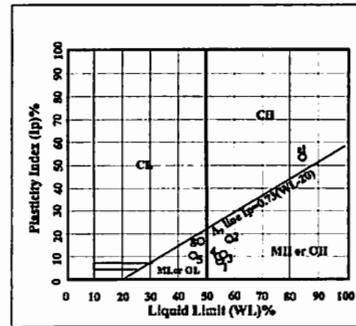
**Figure 3 : Plasticity Chart of all samples**

Consistency limit of the soil samples from C-block of Okimi landslide did not differ much. The liquid limit of sample no. 1, 2, 3 and 4 were measured to be 54%, 58%, 56% and 54% respectively (Table 1). Likewise, the plastic limit of those samples were 46%, 40%, 45% and 44% respectively. For the sample of A-block i.e. sample no. 5, the liquid limit and plastic limit were 45% and 34% respectively. For D-block, sample no. 8 was tested. The measured liquid and plastic limits were 48% and 32% respectively. The sliding surface soil, revealed by boring, was remoulded and consistency tests were performed. The liquid limit and plastic limit of that soil was measured to be 84% and 30% respectively.

There is good correlation between the liquid limit and residual  $\phi$ . The tested data correspond well with the data given by Mesri and Diaz (1986). This indicated the possibility of rough estimation for residual  $\phi$  by careful consistency limit test. Almost all of the samples were supposed to be inorganic silt with medium plasticity whereas sliding surface clay was supposed to be inorganic clay with high plasticity. This difference was occurred due to large amount of finer particles, while testing the consistency limit of the later. For consistency limit test, 2mm down particles were tested, except for sample nos. 2 and 4, which were tested with 425  $\mu$  down particles too.

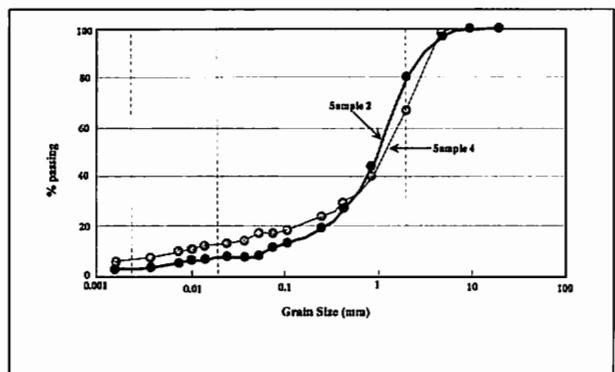
**Figure 4 : Grain size Distribution Curve**

Grain size analysis was done for few representative soil samples after complete drying. First, 1 kg sample was sieved by consecutive set of sieves and hydrometer analysis was done for only small portion of the sieved soil samples. That might have measured the clay composition, in lower range than reality. Sieve analysis was done for the sample no. 2 and 4 only. According to the result, the percentage of clay, silt, sand and gravel at sample no. 2 of Okimi landslide were 4%, 7%, 69% and 20% respectively (Table 2). Likewise those for sample no. 4 were 8%, 9%, 50% and 33% respectively.

The percentage of clays measured by grain size analysis were comparatively small. In fact, 2mm down soil particles were tested during constant consolidation stress ring shear test and 425  $\mu$  down soil particles were tested during constant overconsolidation ratio ring shear test. If the percentage of clay will be recalculated among the 2mm down particles only, then considerable clay percentage can be noticed. That might be responsible to provide about 0.5mm thick clear shearing zone after attaining the residual shear strength. The shape of grain size distribution curve for sample no. 2 and 4 were similar. According to the textural classification, both the soil samples were sand to sandy loam.

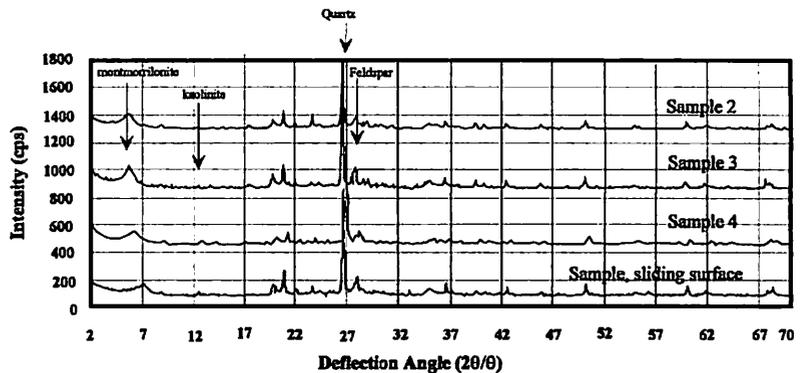
**Figure 5** : x-ray diffraction result

Representative soil samples were powdered well to pass through the x-ray. According to the diffracted result, all the soil samples at Okimi landslide, were mainly, composed of quartz, feldspar, montmorillonite and kaolinite although their proportions were different. Soil sample no. 2 at Okimi landslide was composed of 60% quartz, 22% feldspar, 3 % kaolinite and 15% montmorillonite (Table 3). Likewise, percentage of quartz, feldspar, montmorillonite and kaolinite in sample no. 3 were 59%, 23 %, 15 % and 3 % respectively. At sample no. 4, these proportions were 54%, 26%, 15% and 5% respectively. The sliding surface soil at Okimi landslide was composed of 65%, 18%, 13% and 4% of the aforesaid minerals respectively.

According to the mineralogical analysis, all the soils in Okimi landslide are rich in quartz mineral, if we analyze the whole soil. As finer particles are found to be responsible for the shear surface formation, the proportion of clay might play main role for residual shear strength. Due to this reason, clay fractions were separated in the laboratory using Stoke's method and diffracted through x-ray diffractometer. The result showed, the proportion of montmorillonite was higher than others and were almost similar in all the samples, if total soil will be analyzed. Small proportion of kaolinite could also be detected in all the soil samples. The high proportion of montmorillonite might be responsible for less residual shear strength.

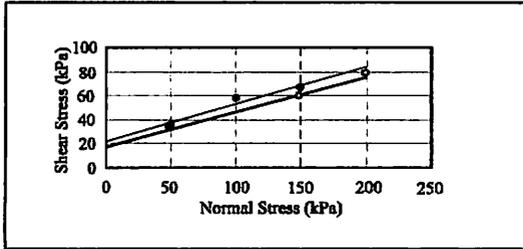
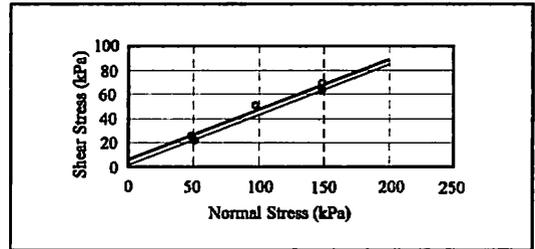
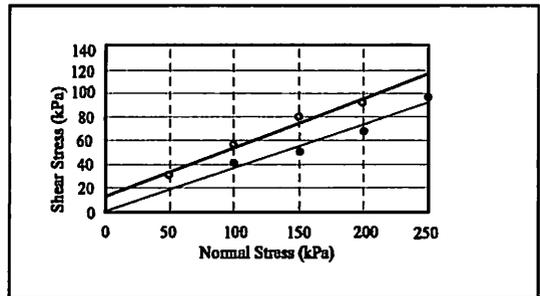
Figure 6 : Residual shear strength envelopes by both ring and simple shear test

All samples were not tested by simple shear apparatus, as the main objective of shear testing, in this study, was to compare the value of residual  $\phi$  after the test with that by the ring shear test. Therefore, the 2mm down samples, only from sample no. 1, 2 and 4, collected on September 1, 1998, were tested by simple shear apparatus. According to the test result (Table no. 4), peak and residual  $\phi$  of sample no. 1 were 17° and 15° respectively. The value of peak and residual c were 29 kPa and 20

kPa respectively. Likewise the peak and residual  $\phi$  of sample no. 2 were  $26^\circ$  and  $15^\circ$  respectively and value of  $c$  were 5.1 kPa and 12 kPa respectively. The peak and residual value of  $\phi$  at sample no. 4 were  $17^\circ$  and  $22^\circ$  respectively. The value of peak and residual  $c$  there, were 23 and 23 kPa respectively.

Peak shear strengths were measured by both ring and simple shear apparatus. The value by ring shear apparatus was higher than the simple shear apparatus in many cases. That might be due to difference in testing conditions. In fact, there is no meaning to test the peak shear stress while analyzing the landslides, unless the undisturbed sample is to be tested.

composition is found to be dominant for the residual shear strength. Sample no. 1 was tested on 2mm down particles only, with both simple and ring shear tests. Both tests gave the similar value of residual  $\phi$  i.e.  $15^\circ$ . Sample no. 2 was tested with various methods i.e. on 2 mm down soil by both apparatus, ring shear test on  $425\mu$  down soil and multistage ring shear tests. All the tests gave the residual  $\phi$  between  $15^\circ$  to  $16^\circ$ , except that by testing  $425\mu$  down soil with constant o.c.r. of 4 ( $22^\circ$ ). First, it was surprising result, but, after multistage test, the curved failure envelope was confirmed and the larger value of residual  $\phi$  at lower normal stress range was proved obvious. Residual  $\phi$  of 2 mm down soil from sample no. 3, by ring shear test, was  $16^\circ$ , which was similar to that of sample no.1 and 2. However, sample no. 4 always gave higher residual  $\phi$  than others. Almost all of the test methods gave residual  $\phi$  closer to  $22^\circ$ , except the test with o.c.r. of 4 ( $25^\circ$ ), which was understood obviously, as explained above for sample no. 2.

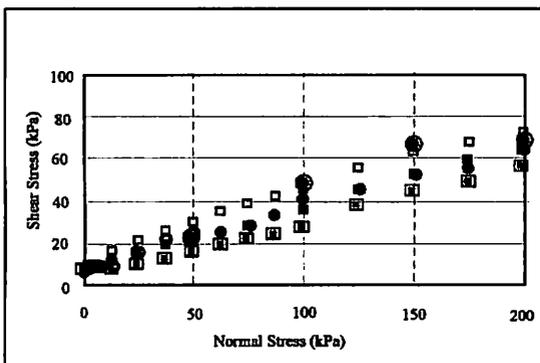
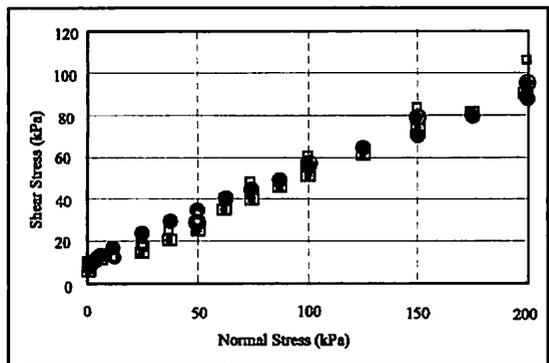
Figure 7 : Ring shear tests by all methods, Okimi 2 and 4

- 2 mm. down sample, individual loading test
- 425 $\mu$  down sample, individual loading test, o.c.r. 4
- Multi-stage ring shear test, increasing load condition
- Multi-stage ring shear test, decreasing load condition
- Multi-stage ring shear test, 1 cycle loading, decreasing stage
- ▣ Multi-stage ring shear test, 1 cycle loading, increasing stage

As the main target of this study was to check the residual shear strength of various soils, extensive ring shear tests were conducted, using various methods (Table no. 5). First, 2mm down soil particles of various samples were tested with individual ring shear test with varied normal stress, at the constant overconsolidation pressure of 200 kPa. The soil sample no. 1 exhibited the peak and residual  $\phi$  of  $27^\circ$  and  $15^\circ$  respectively. The value of peak and residual  $c$  there, were 12 kPa and 9 kPa. respectively. Likewise, sample no. 2 gave peak and residual  $\phi$  of  $29^\circ$  and  $16^\circ$ , respectively. Value of  $c$  in peak and residual stage for that sample were 12 kPa and 5.6 kPa. respectively. In sample no. 3, peak and residual  $\phi$  were  $30^\circ$  and  $16^\circ$ , respectively, whereas  $c$  were 20 kPa and 4 kPa, respectively. While testing sample no. 4 with the similar method, it gave peak and residual  $\phi$  to be  $30^\circ$  and  $22^\circ$  respectively and  $c$  to be 21 kPa and 6.5 kPa. respectively.

After the soil testing by the aforesaid technique, finer particles of the ( $425\mu$  down) soils were tested with constant overconsolidation ratio of 4 to compare the result. For this purpose, the soil sample no. 2 and 4 were selected and were collected on October 6, 1998. After the soil test, the peak and residual  $\phi$  at sample no. 2 were measured to be  $38^\circ$  and  $22^\circ$  respectively. The peak and residual  $c$ , there, were measured to be 11 kPa and 5.6 kPa. The peak and residual value of  $\phi$  at sample no. 4 were measured to be  $39^\circ$  and  $25^\circ$ , respectively,

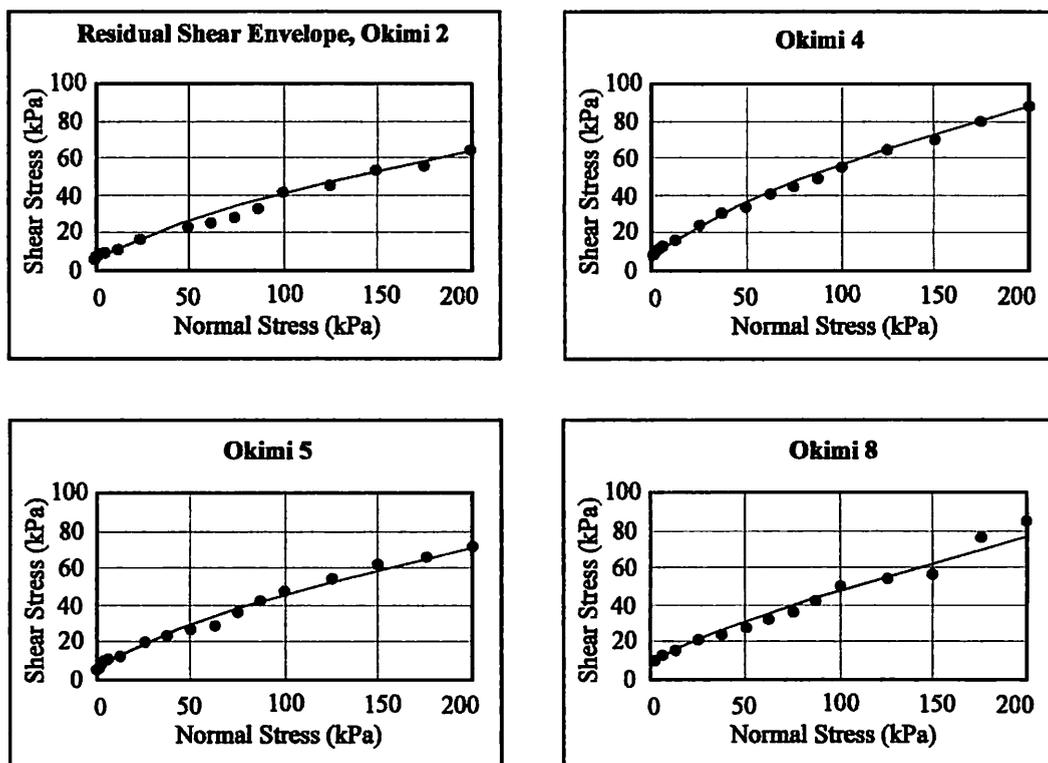
Figure 8 : Residual shear envelopes of sample no. 2, 4, 5 and 8 by multi-stage ring shear test

After all the above mentioned tests, sample no. 2 and 4 were tested by multistage ring shear. This was done to overcome the possible errors due to dissimilarity of two different samples, while testing individual samples in former methods. "If the residual shear strength is mainly generated due to parallelmost orientation of the soil minerals, then this method would be the best one", was the concept to use this method. Therefore, 425  $\mu$  down sized particles of sample no. 2 and 4 were tested again, by this method. Peak value can not be reliable in this method. The residual  $\phi$  of sample no. 2 and 4 were found to be 16° and 22° respectively whereas the value of residual  $c$  in these two samples were measured to be 6.6 kPa and 5.6 kPa. respectively. Likewise, curved shear envelope, rather than the assumed straight lined one (assumed by Colomb's equation), was found by testing the soil up to the possible minimum value of normal stress. That selfexplained the reason for the increase of  $\phi$  during the second test condition with constant O.C.R. of 4, which was done for low normal stress range only, due to the limitation of testing equipment. The value of residual shear strength was not so different, for different size of particles or different testing modes and different overconsolidation ratios. Hence, sample no. 5 for A block, 8 for D block and sliding surface soil from A block were tested by multistage ring shear test on 2mm down soil particles. According to the result, the residual  $\phi$  at sample 5, 8 and sliding surface soil were measured to be 12°, 19° and 10° respectively whereas residual value of  $c$  were measured to be 5 kPa, 7 kPa and 6 kPa respectively.

Due to the aforesaid reasons, the shear strength data provided by the multistage ring shear test of sample no.2 was used for the stability analysis of block C, Okimi landslide. The analyzed section is closer to this location. As it was understood that residual strength given by multistage ring shear test is most reliable one for landslide analysis of repetitive rotational slides, soil samples from the main scarps of other blocks were tested with multistage ring shear test after sieving them by 2 mm sieve. Sample no. 5, from the main scarp of block A, had the residual  $\phi$  of  $12^\circ$  which was slightly higher than the remoulded sliding surface soil, which had residual  $\phi$  of  $10^\circ$ . It was very difficult to test the sliding surface soil due to its stiffness and low permeability. The test was failed for many times. It took almost 10 times more test durations than the main scarp soils to yield the residual value. Although the residual value was almost equal with main scarp soil for lower normal stress range, it was slightly gentler for higher normal stress range. The main scarp soil of D-block yielded the residual  $\phi$  of  $19^\circ$ . This value was utilized for stability analysis. It is to be noted here, that almost all of the samples yielded some small values of  $c$ , when the soil test was conducted for negligible normal stress. This was found to be real property of those soils rather than the effect of self weight.

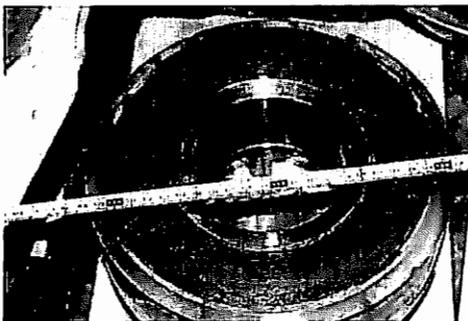
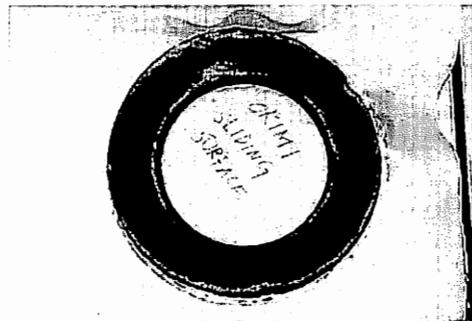
**Photo 3** : Final shear plane formed after ring shear test (about 0.5mm. thickness)

Sample no. 2 after individual test

Sliding surface soil after multi-stage test

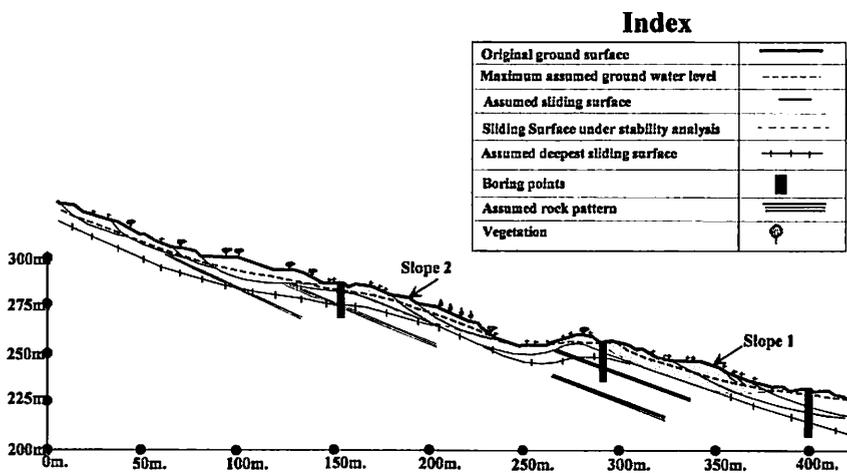
Figure 9 : Cross-section of Block C along A-A

**C-Block:** Stability analysis of C Block along some surveyed crosssections was done, once, in 1979. During that time, stability analysis was done with  $c$  as 10 kPa (assuming slide surface

depth of 10m) and  $\phi$  was calculated by back analysis. Surveyed maximum water table was utilized during the analysis. With proposed factor of safety of 1.15, counter measures were planned and applied. Same section and the same data except  $c$  and  $\phi$  were utilized in this study too. Here,  $c$  and  $\phi$  obtained by the ring shear test on sample no. 2 was utilized. Stability analysis for both upper and lower sections of crosssection A-A were done. Slope 2, lying at steeper slope was found to be unstable during that time while slope no. 1 was in critical condition with the factor of safety of 1.03 (Table 7). But the water table, decreased after the construction of extensive drainage network, might have stabilized this block, although minor displacements of few cm per year were recorded. This small movement might be due to the movement of A block in oblique direction, which might have induced the loss in the toe support of C-block. The numbers of functioning piezometers in the landslide area, to confirm the ground water table after countermeasure application, are very less. Therefore, the data from the nearby piezometers were utilized for analysis.

$\Sigma$  102.1  
 $c=$  6.6  $\phi=$  16 FS= 1.036 With tested  $c$  and  $\phi$   
 $c=$  10  $\phi=$  13.15 FS= 0.999 back analysis method with  $c=10kPa$

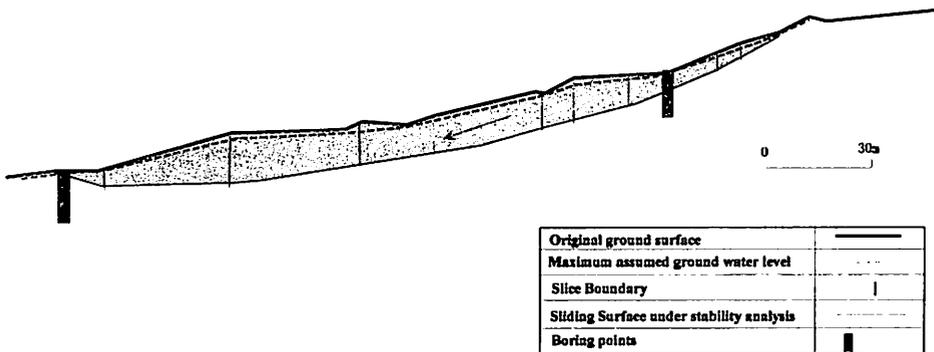
**Figure10 : Cross-Section of Section A-A, Block D**

**D-Block:** No stability analysis was done for D-block too in the past. Hence, the section surveyed in the past with the ground water information at that time was used for stability analysis. Soil test data of sample 8, the main scarp of D block, were used. The block was found to be unstable, but, no countermeasures are applied in this block. The evidence of water accumulation in the form of pond was also found in this block. In fact, this block was recorded to be fastest in movement, with the rate of few meters per year. This movement might have caused the loss of the support for the toe of A-block, and A-block also moved inspite of heavy drainage works. No important land and infrastructures are located in D-block. That might be the main reason for not implementing any countermeasures in D-block.
