— ORIGINAL ARTICLE —

Effect of post type and loading condition on the failure resistance and primary failure mode of flared canal teeth restored with fiber-reinforced or cast posts

Key Words : cast post-and-core, failure mode, failure resistance, fiber-reinforced post, flared canal

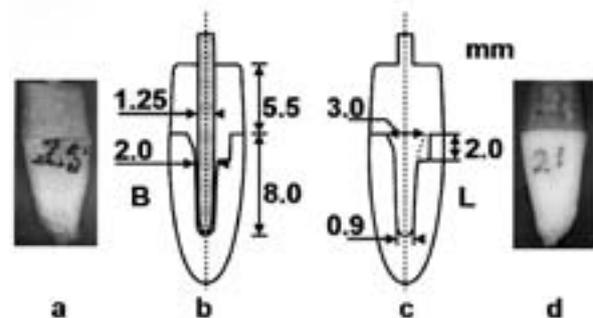
Fig 1. Photographs of specimens before mechanical testing and schematic diagrams of root canal preparation and post & core design (dimensions in mm): a and b, with glass fiber-reinforced composite resin post and glass fiber-reinforced core build-up material; c and d, with cast post-and-core. (B = buccal, L = lingual).

The canals were prepared to receive posts (Fig 1) to a depth of 8 mm with #1 through #3 Peeso reamers (MANI Inc., Ustunomiya, Tochigi, Japan) and #1 through #2 tapered reamers (RTP Reamer, Dentsch, Tokyo, Japan). On the lingual aspect, a keyway type antirotational groove was also prepared with a diamond bur. Thereafter, the canal was flared in the cervical area by a conical carborundum point, to simulate the preparation required in gross carious destruction (Fig 1). In all the specimens, the mesiodistal width of the remaining tooth structure in the cervical area was 1 mm on each side.

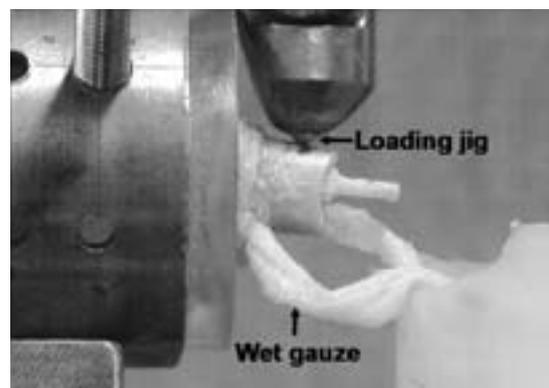
Fig 2. Fiber specimen mounted in the brass holder of a lever-type fatigue testing machine. The wet environment during the cyclic loading was created by wet gauze, which emerged from a recipient filled with water and encircled the cervical portion of the root.

Half of the cast and half of the fiber specimens were firmly mounted in a brass holder of a custom-made lever-type fatigue testing machine.²⁴⁾ Serrate-type cyclic loading between 0 and 2 kgf (19.62N) was applied to the buccal face of the core, 4 mm from the cemento-enamel junction (Fig. 2). The load was applied at a rate of 80 cycles/min (1.33 cycles/s) for 900,000 cycles in a wet environment at room temperature. During each cycle the specimens were loaded for 0.3 s. The machine was equipped with 2 types of shutoff sensors to automatically discontinue loading in case of specimen failure.

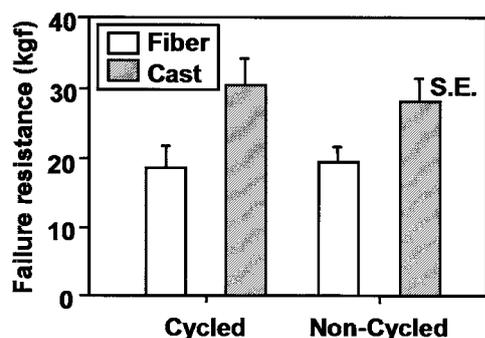
Fig 3. Bar chart of the mean failure resistance values and standard error of the mean (SEM) for each group (kgf): fiber specimens (Fiber) submitted to cyclic loading (Cycled), cast specimens (Cast) submitted to cyclic loading, fiber specimens not submitted to cyclic loading (Non-Cycled), and cast specimens not submitted to cyclic loading.

loading and humidity ensured the post fit into the flared canal. In the fiber specimens, the adhesive resin cement, matrix resin of post, and composite resin might have been deteriorated by the fatigue test in the wet environment and this may have allowed for a greater deflection and thus a larger deformation of the more flexible fiber-reinforced post. This put a higher burden on the weakest tooth-adhesive cement-composite resin interfaces, which therefore failed at lower loads than the weakest link of the tooth-restoration complex in the cast specimens. In contrast, the more frequently encountered root fracture and resistance to higher loads in the cycled cast specimens can be explained by the higher stiffness of these posts, as compared with the glass-fiber reinforced posts and the cervically added composite resin. Higher loads were needed to deflect them, and thus a higher burden was concentrated in the cervical region of the surrounding tooth structure. This ended up in more root fractures. Once a fracture occurred, a higher burden was transferred to the tooth-cement interface and slight debonding (gaps) followed immediately in half of the cycled cast specimens. On the other hand in the absence of cyclic loading, the difference in stiffness of the 2 posts could explain the tendency of higher failure resistance in the cast than the fiber specimens; however, in the absence of the fatigue test in wet environment, the tendency did not reach significance (Fig 3).

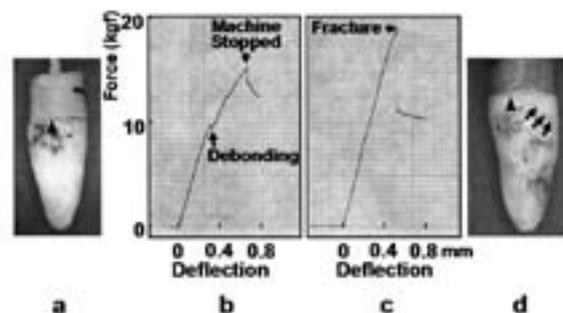
Fig 4. Stereoscopic aspects and force-deflection curves of failed specimens: a and b, fiber specimen failed by debonding (arrow head); c and d, cast specimen failed by root fracture (arrows). A slight gap of short span (arrow head) is also visible at the tooth-core interface.

The aspect of the force-deflection curves (Fig 4b and c), in combination with the visual and stereoscopic inspection of the failed specimens (Fig 4a and d), revealed the following modes of failure: debonding of the post and core (13 specimens) and root fracture (27 specimens). In 22 of the root-fractured specimens, an oblique fracture line was visible in the cervical quarter of the root. This crack started at the cervical surface of the root on one proximal aspect and descended towards the lingual aspect, on which its most apical level was observed about 1 mm beneath the embedment resin surface. In many specimens, the crack then rose on the opposite proximal aspect towards the cervical surface of the root where it ended. In the other post-fractured specimens, 3 vertical root fractures and 2 apical root fractures were recorded. Furthermore, in 10 of the root-fractured specimens (5 cycled cast, 2 cycled fiber, and 3 non-cycled cast specimens) slight gaps were also observed microscopically at the core-dentin interface.
