Mass movement problems along Prithvi Highway, Nepal

Abstract

Keywords : Mass movement, Landslide, Prithvi highway, Topography, Geology

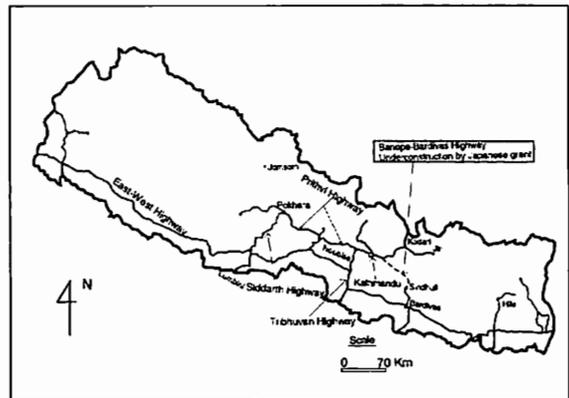
Fig. 1 : Schematic map of Nepal showing Important highways.

One of the most important national highway, East-West highway, runs along the low land of Terai in the southern part of Nepal which connects the eastern part of Nepal with the western part. This main highway links the capital city Kathmandu by two routes (1) by Tribhuvan highway, (2) by Prithvi highway through Mugling. Besides that there are limited numbers of North-South routes, which link the East-West highway. Among, the two highways which connects the capital city Kathmandu, Prithvi highway is the important one because Tribhuvan highway has very narrow lane, tortuous bends, steep gradients and above all, runs up to the height of 2100m above mean sea level. The journey through this highway is very tough. Most of the people do not want to travel through this highway. Therefore this highway bears negligible traffic volume these days (Fig.1).

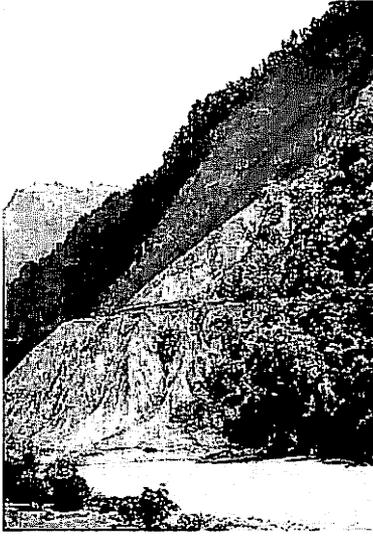
This massive landslide is located around 78km from Kathmandu towards Pokhara. It was first occurred on August 11, 2000 blocking the traffic for 11 days. The debris buried the road up to 10m height and excess of which had flown down to the river. The fallen rocks and soil impeded the river's water flow for almost fifteen minutes forcing the people of near by village to escape from the area at night. This year also it stopped the traffic twice for a couple of days and the department of road had to have great effort to open this road. At present this landslide seems stable. All the debris have been removed and thrown to the Trishuli River and huge gabion wall has been constructed to check the further debris flow.

The total width and height of this landslide were 200m and 220m respectively from road level and average gradient was 35 degrees on August 15, 2001. The total volume produced by this landslide was estimated about 380,000m³. It is said that all the debris fallen into the Trishuli River had been washed away by its current (Photos 1, 2).

The area is composed of gray argillaceous slate and phyllite of upper Nuwakot formation of Paleozoic era. As per the experts of Nippon koei Co., the collapsed landslide was a part of huge rock type landslide, which was located behind the collapsed landslide.

Photo 1 : View of Krishanabhir Landslide from Pokhara side.

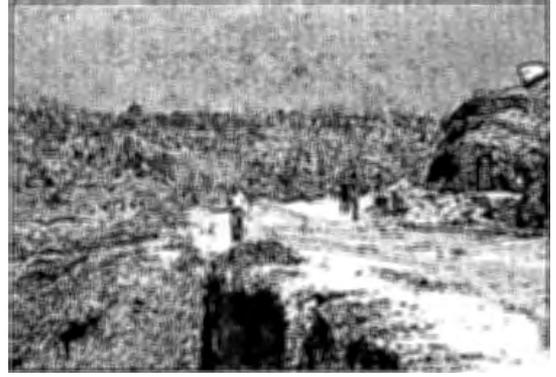
Photo 2 : View of the condition of road at Krishanabhir on September 22, 2001. Notice the preventive work is going on to check the debris flow.

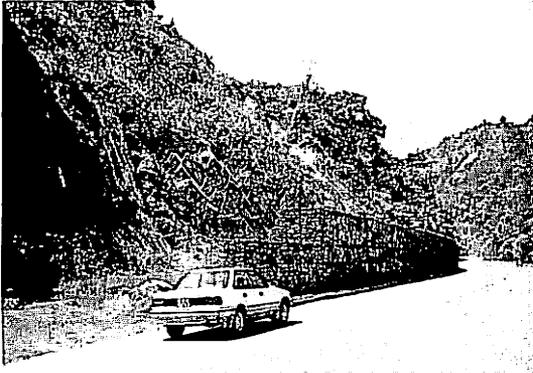
Photo 3 : View of the present situation of Jogimara Landslide and the road. Notice the massive control work.

The Jogimara landslide, located at the slope close to the old limestone quarry, has been remained a most hazardous landslide between 80's to 90's along the Prithvi highway. It has carried several buses and trucks into the Trishuli River and hundreds of people lost their lives. The slide lies on Benighat slates and Jhikhu bands. The geology of area consists of limestone, black schists and slate. The rocks are extremely jointed and the joints spacing vary from a few centimeters to tens of centimeters in the slate and from tens of centimeters to a few meters in the limestone. At the time of massive landslide in 1993, the natural slope of this landslide was found 40 degrees to vertical and the collapsed slope was 30 degree. The length, breadth and depth were found about 70m, 80m, and 15m respectively.

At present the Jogimara landslide is under control. The department of road HMG/N has excavated the great amount of weathered materials and constructed the massive gabion walls at landslide area (Photo 3).

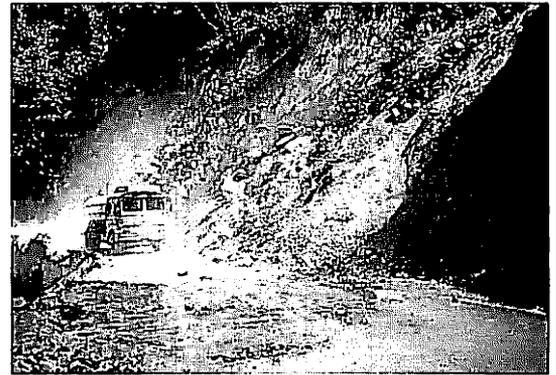
Photo 4 : View of Nagdhunga Landslide from Kathmandu side and the condition of Road on September 21, 2001.

This landslide located at about 12.5km west from Kathmandu has occurred on September 9, 2001 and blocked the busy traffic for couple of hours (Photos 4, 5).

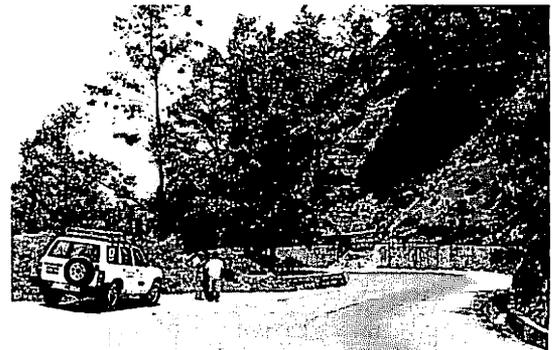
Photo 6 : View of the landslide Control Work at Nagdhunga, 12.0km west from Kathmandu.

There are other two landslides, located near this landslide at 12.0km and 15km from Kathmandu where protection and stabilization works has been recently completed by department of water induced disaster prevention (Photos 6, 7).

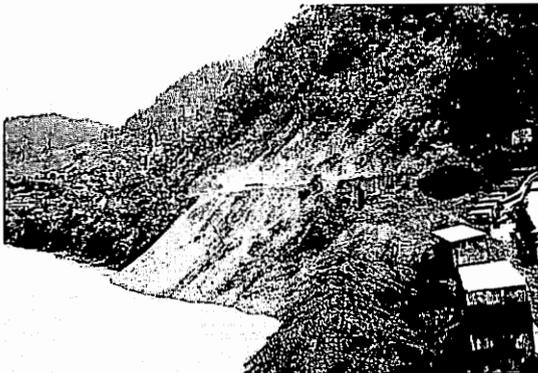
Photo 9 : View of Landslide near Dahaki Khola from Pokhara Side where the Road settle due to the bank erosion.

This landslide has occurred in August, this year. Part of Prithvi highway had been washed off, when about 100m of road sank near Dahaki Khola. In addition, landslides occurred at the hillside blocked the highway for a couple of days. Currently vehicles are moving above the deposited debris (Photos 8, 9, 10).

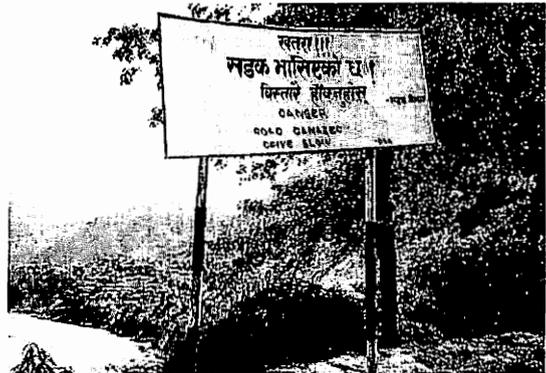
Photo 10 : Sign of Danger kept by the Department of Road (DOR), the only authority who construct and take care of Road in Nepal, stating that drive slowly, the Road has damaged (settled).

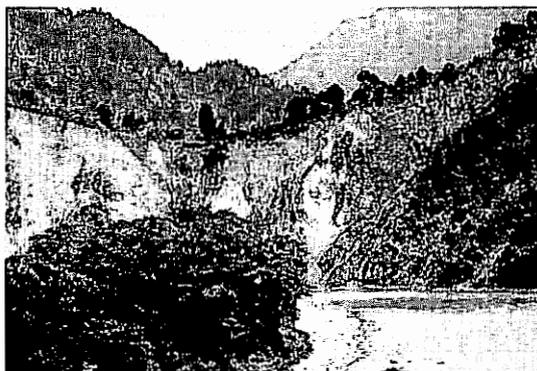
Photo 11 : View of bank erosion at opposite side of the Highway

Aforesaid are the major landslides along the Prithvi highway. Some of them are fresh and have occurred this year during monsoon. Besides, there were about 44 large and small landslides found during our field visit along that highway up to Mugling. This brings forth the vulnerability of this highway. Every year new landslides are developed and the older one becomes more and more dangerous. As this road is running along the side of the river, bank erosion is also frequently occurred. The most vulnerable areas along this highway up to Mugling are around Jogimara, near Bishal Tar, Malekhu, in the vicinity of Belkhu, Galchi, Mahadevbesi, Noubise, Kurintar etc (Photo 11).

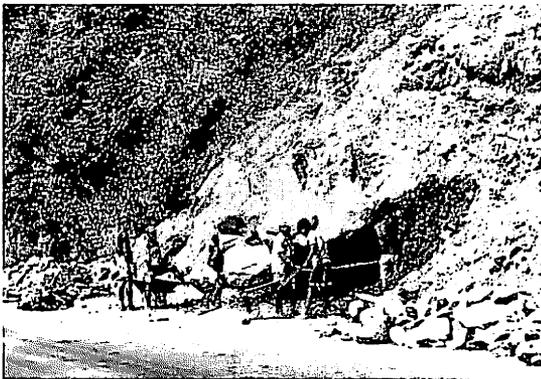
Photo 12 : View of Roadside quarrying work along Prithvi Highway.

at some parts of this highway, which has made the slope more vulnerable. People used to graze their cattle on the hillside also. We also noticed quarry sites both on hillside and valley side. Though mining activities less than 50 meters from the highway is banned in Nepal, we found that several people were quarrying out limestone from the slopes, which have further aggravated the fragile condition of roads. The worst thing that we found was that people were extracting out sand, gravel and boulder along the steep channel of the riverbed. It increases the vulnerability to the riverbank and bridge foundation (Photos 12, 13, 14).

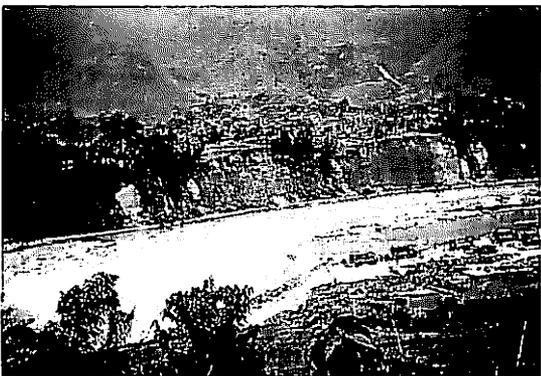
Photo 13 : View of River bank erosion and extraction of sand and other materials along the River channel.

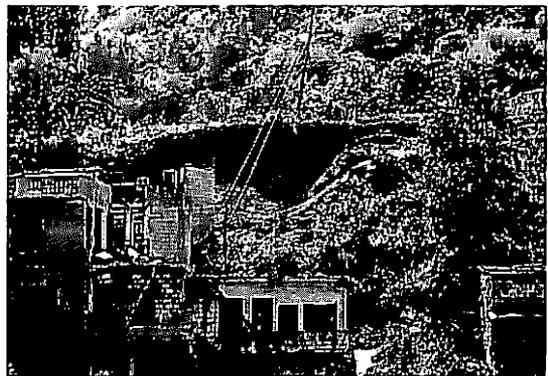
Photo 14 : View of landslide along Prithvi Highway threatening the adjacent houses.
