Landslide Investigation and Prevention Practice in Nepal

Tiwari Binod* and Marui Hideaki**

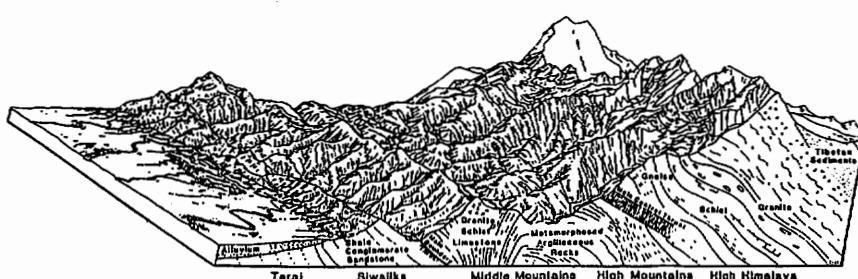
Figure 2 : Physiography of Nepal

The topography of Nepal varies drastically from low lying areas of the Gangetic plain with an altitude less than 100 m. in the south to Himalayas with an altitude of 8848m. in the north within a short horizontal distance of 90-120 km. Such gradient is responsible for the induction of frequent landslides in Nepalese hills. The flat plain with an altitude ranging 100-400m. covers almost 17% of the country where no landslide problems are encountered. Among the rest 83% land, 60% of the total land, existing at an altitude ranging several hundred

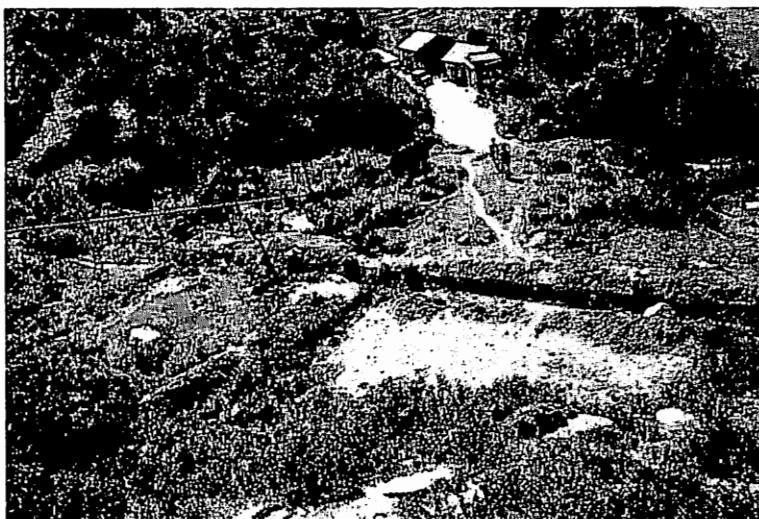
Photo 4 : Landslide at 19 km. along Kathmandu- Trishuli Road

Kathmandu-Trishuli Road: This road, joining the 70 km. distance between Kathmandu to Trishuli was first constructed as access road for Trishuli Hydro-electric Project. This is strategic road to connect Somdang, which is another border to China. Many fault lines also cross the road sector. The MCT is crossed by the road at about km. 48., which induced heavy landslide. Besides, there are many local faults along which frequent landslides can be observed. The landslide at 19 km. is the prominent one, which was first triggered due to the earthquake of 1942 and activated many times due to hydrological as well as artificial causes like road cutting. The collapse of this 110 m. long landslide may affect a lot in the economy of the northern sector, but is almost stabilized after the intensive investigation work. As the slide is passed by the local fault line, dense landslide geo-morphology can be seen along the fault line.

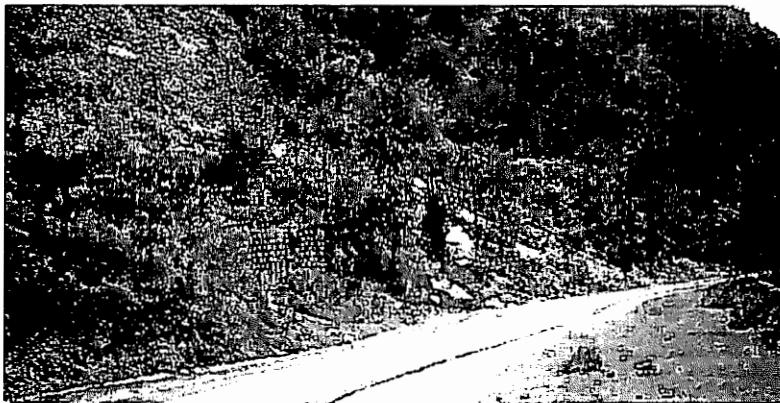
Photo 5 : Lumle landslide induced due to hydrological and geological cause

Pokhara-Baglung Road: This is 72 km. long highway connecting Pokhara with northern town Baglung. As this road is also running northwards, frequent landslides encountered on the way create disturbance to thorough traffic. The big landslide at Lumle is creating havoc to the road managers as the whole hillside is converting to landslide. This landslide starts from the folded joint of phyllite and ends at the stream several hundreds meter downstream. Besides this, several landslide topography at off-road right bank of the stream can be observed which might be dangerous in future.
