1995 Northern Niigata Earthquake of M6.0 and a Buried Fault Imaged by Distribution of Seismic Intensity

Yasue ŌKI, XU Huilong, Naoki WATANABE,
Koji SUZUKI and Osamu SATO

Research Institute for Hazards in Snowy Areas, Niigata University

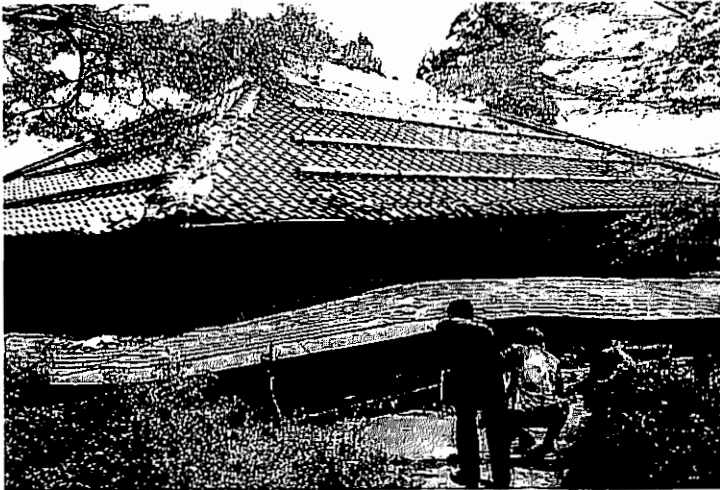
Photo 1 Pancake collapsed Kogetsukaku guest house, Ichishima landlord, a cultural heritage of Niigata Prefecture, Tenno, Toyoura Town.

Toyoura station of the JR Uetsu line. According to the Fire Protection Section of Niigata Prefectural Government, 6 persons were heavily injured, 62 persons were wounded, but no one died. The Kogetsukaku Guest House of the Ichishima landlord, a cultural heritage of the Niigata Prefecture was completely collapsed (Photo 1). In total, 55 houses were completely collapsed, 165 houses were half collapsed, 783 houses were partially destroyed. About \$930 millions of total loss was estimated. The main shock was felt not only in the Niigata Prefecture, but also in its surrounding prefectures as shown in Fig.1. Building failures are analyzed by Isoda (1995) and disasters of irrigation facilities are examined by Misawa *et al.*(1995).

fault plain were more intense than N-S direction. It is noted that the wooden houses built by the “two by four” method of wall structure since 1974 were not destroyed even at the epicenter area. The Kogetsukaku guest house of the Ichishima landlord built in 1897 was collapsed by the main shock in pancake collapse. At that moment, a couple of husband and wife just visiting this guest house was placed under the ruins of the Kogetsukaku guest house. The husband fortunately escaped by himself, but his wife was caught by the pancake collapsed. After 50 minutes, she was safely rescued by the firemen. As seen in Photo 1, the guest house was covered with heavy tiled roof of 100 years old and constructed on a soft ground of the Fukushima lagoon. Thus, they said that it was easily collapsed by the earthquake no matter the intensity of the shock small. There is a tea-house close to the guest house settled on stone foundations. The tea-house was displaced by 10 cm to west without any streak of wooden powder on the stone surface like the case of the Kumano shrine and suggests that strong vertical motion larger than the terrestrial gravity hit the tea-house of the Ichishima residence.

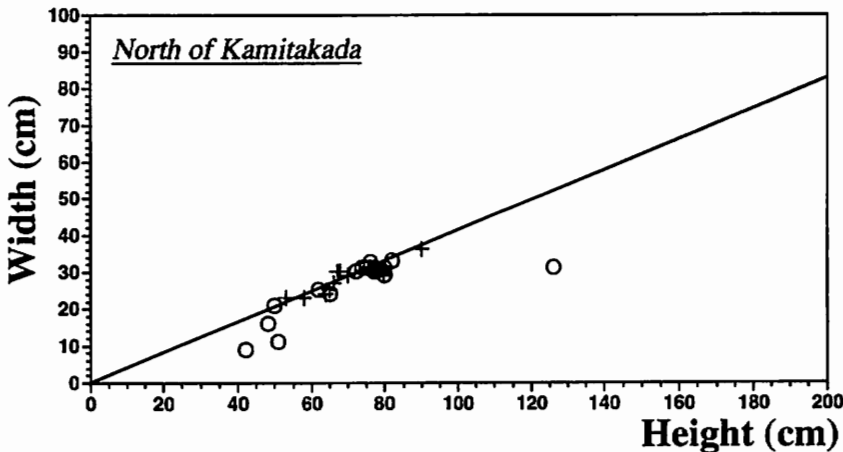
Fig.2 Height-width diagram for the calculation of horizontal acceleration of earthquake from stable gravestones (+) and overturned gravestones (O). The inclination of boundary line provides k value for maximum earthquake acceleration (North of Kamitakada grave yard).

In Japan, most of gravestones are rectangular type, which is convenient to estimate the horizontal acceleration of earthquake based on the moment of overturned gravestone. The horizontal acceleration of earthquake motion can be calculated by the following formula: $\alpha = k \cdot g$, where α is a maximum horizontal acceleration, k is the factor of overturn, calculated by the ratio of width to height of overturned gravestone and g is the acceleration of the terrestrial gravity. The critical boundary line between the plots of overturned gravestones and of stably standing gravestones in the height-width diagram provides k value for the calculation of the maximum horizontal acceleration of earthquake (Fig.2). The list of maximum horizontal accelerations is given in Table 1 and the areal distribution is shown in Fig 3.

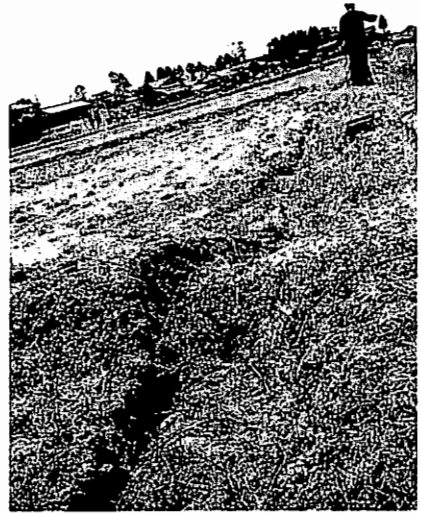
Photo 4 Straight crack 620m long appeared in the paddy field of the epicentral area, Kamitakada, Sasakami Village.

A 620m long straight crack with N20°E direction developed in the paddy field from Kamitakada to Takada of the epicentral area. There is a 1m deep irrigation canal by 2m west from the crack. The direction of the crack is parallel with the canal. By strong quake, the soil of paddy field slid by several centimeters toward the canal and fractures of 10cm wide at maximum opened (Photo 4). There were a lot of small scale cracks appeared in the firm yard around the Kamitakada hamlet, too.

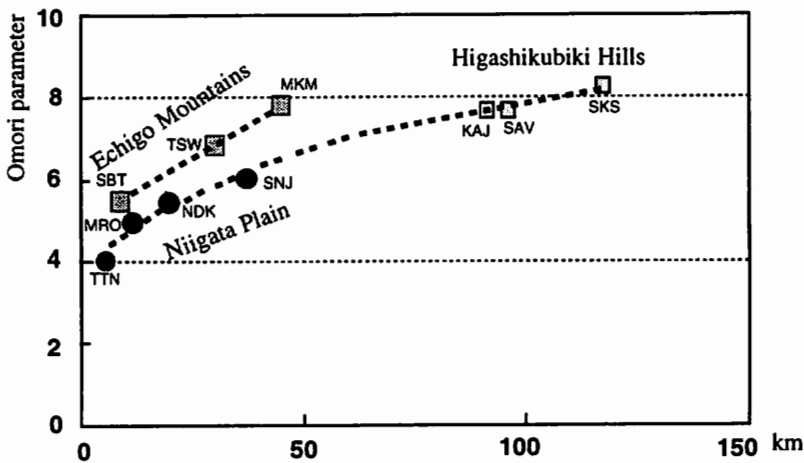
Fig.6 Spatial variation of the Omori parameter vs. epicentral distance diagram. Abbreviations are seismogram stations.

minutes, our seismometer at the epicenter could not record the main shock. The epicentral area of the northern Niigata plain is almost boundary between the thick pile of Neogene sediments and the older complex of granite and metamorphic rocks forming the basement of the Neogene. Simple layer structure of seismic wave velocities can not apply for the epicenter calculation. We obtained the origin time of each shock by the Wadachi's graphic method and calculated the Omori parameter. Fig.6 is the spatial variation of the Omori parameters showing big difference between the Niigata plain and the Echigo mountain. It is noted that the Omori parameter is considerably small in the Niigata plain.

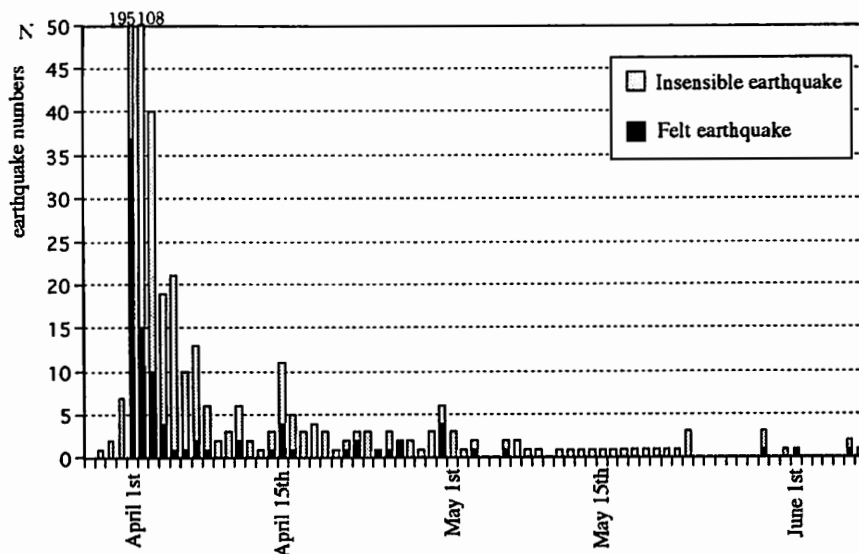
Fig.8 Temporal variation of the daily number of earthquakes recorded at the Tokushoji temple.

The distribution of epicenters including the main shock has been analyzed as shown in Fig.7 by the seismic records of the Niigata University together with those by Niigata Prefectural government. The focal mechanism analyzed by the Tohoku University (1995) is that E-W maximum compressive stress ruptured a reverse fault with NNE-SSW or NW-SE strike. It is not yet decided whether the earthquake fault plane dips to west or east. The direction of the seismic intensity 6 is different from the strike of earthquake fault analyzed by the Tohoku University. Sakai *et al.* (1995) revealed the distribution of the epicenters with careful attention to depth of the foci. They have pointed that the Northern Niigata Earthquake is regarded as very shallow seismic activity, which takes place at the basal part of the Neogene sediments highly deformed by E-W compressional stress. The daily number of earthquakes observed at our seismogram station at Tokushoji is shown in Fig. 8. The aftershock activity lasted 40 days after the main shock.
