## Surface Contamination of Titanium by Abrading Treatment

This study investigated the contamination of abraded Ti surfaces. Using a polishing machine, specimens were abraded with waterproof SiC grit papers under water cooling. The abraded surfaces were examined using element analysis, X-ray diffraction, and hardness tests. Contaminant deposits with dimensions reaching about 30  $\mu\text{m}$  were observed throughout the surface. In these deposits, Ti was apparently reduced by about 10% and replaced by Si and O. The chemical bond state of the Si was similar to that of SiC or a titanium silicide. The O was solute in Ti, which increased the surface hardness. The contaminant deposits were amorphous or very thin. The contamination of Ti, the extent of which was related to hardness, resulted from a reaction with abrasives.

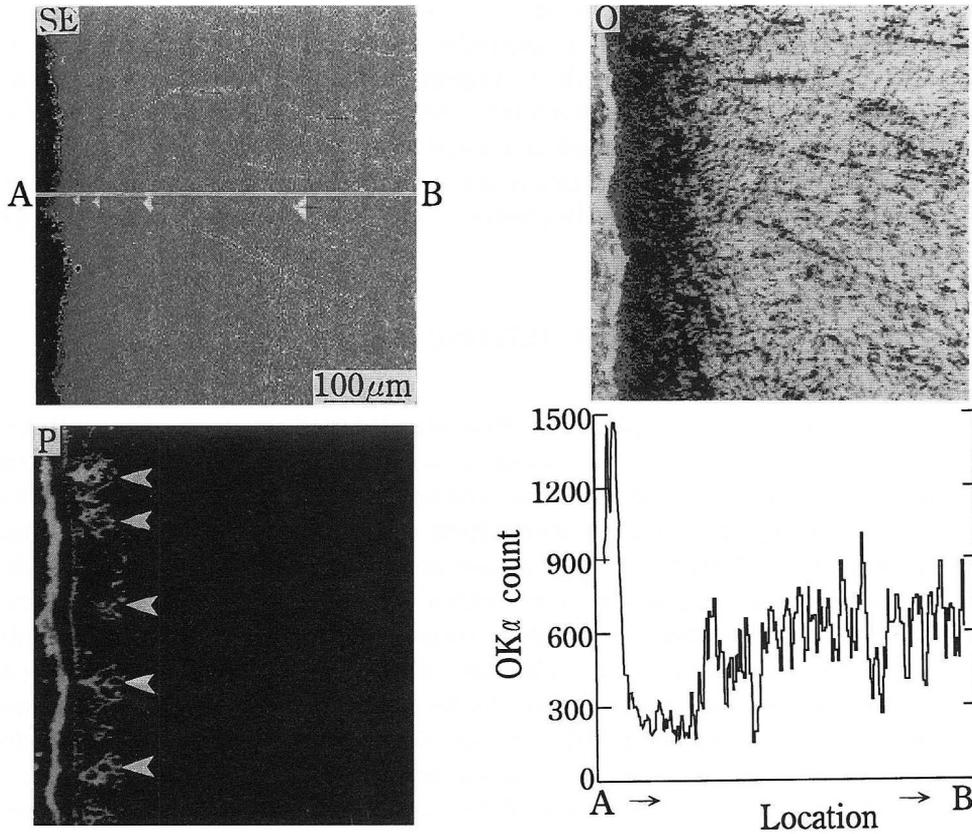
Fig. 1 shows a secondary electron (SE) image of the abraded section of a titanium casting and the corresponding maps of oxygen and phosphorus. The line analysis profile of oxygen distribution along the line AB in the SE image was added to this figure for a semi-quantitative evaluation. The specimen was a casting from a phosphate-bonded silica investment mold. The bright vertical band seen in the oxygen and the phosphorus maps corresponds to the mold-metal interface. A reaction zone<sup>4)</sup> with a width of one hundred  $\mu\text{m}$  or more is observed to the right of the band. The layer between the interface and a layer with a phosphorus-rich phase (indicated by arrow heads) is the so-called oxygen-stabilized  $\alpha$ -case. It has been widely documented that the solute oxygen content is highest near the mold-metal interface and decreases rapidly toward the interior of a casting<sup>4)</sup>. However, Fig. 1 exhibits a remarkable increase and variation in oxygen content, starting from the layer with the phosphorus-rich phase and progressing toward the interior of casting; this is entirely inconsistent with previous reports.

Fig. 1 Element distributions in the reaction zone of a Ti casting abraded to #1,000 grit. The line analysis profile shows the oxygen distribution along the line AB. The four marks along the line AB are Vickers hardness test indentations.

of solute oxygen<sup>4</sup>), exhibiting Hv values ranging from about 200 to 800 or more. On the other hand, the interior of the casting is relatively soft, with a low solute oxygen content, and Hv values between about 160 to 180<sup>6</sup>). In Fig. 1, however, the oxygen content in the reaction zone was apparently low compared with that in the interior of the casting. This means that the hard reaction zone was scarcely contaminated. Similarly, the work-hardened stainless steel clipping band, which was abraded together with titanium, was not contaminated by titanium, oxygen, silicon, calcium, or carbon (data not shown). These facts suggest that the contamination may be related to the hardness of the specimen, because abrasive grits may be embedded in the surface if the specimen is soft or ductile.

As mentioned previously (Fig. 7), the contaminant oxygen was solute in titanium, suggesting the possibility that the oxygen may harden the abraded surface. The Vickers hardness test was performed at forty points on the abraded surface. Hardness numbers varied between 187 and 285, and an average of 228 was obtained with a standard deviation of 24.6. The hardness could not readily be related quantitatively to the contaminant oxygen content, because the size of the Vickers hardness test indentation was comparable to that of the contaminant deposit (Fig. 5). However, the variation of hardness appeared to correspond to the distribution of contaminant oxygen. As with the casting of JIS class 2 titanium, hardness numbers were in a range of about 160 to 180<sup>6)</sup>, not at the reaction zone but in the interior. It is clear that the contaminant oxygen increased the hardness of the abraded surface. In spite of the very high oxygen content, however, the hardness did not reach that of the reaction zone. This was confirmed by a comparison of four Vickers hardness indentations along the line AB in the SE image of Fig. 1. The reason may be that the contaminant oxygen did not diffuse into the interior.

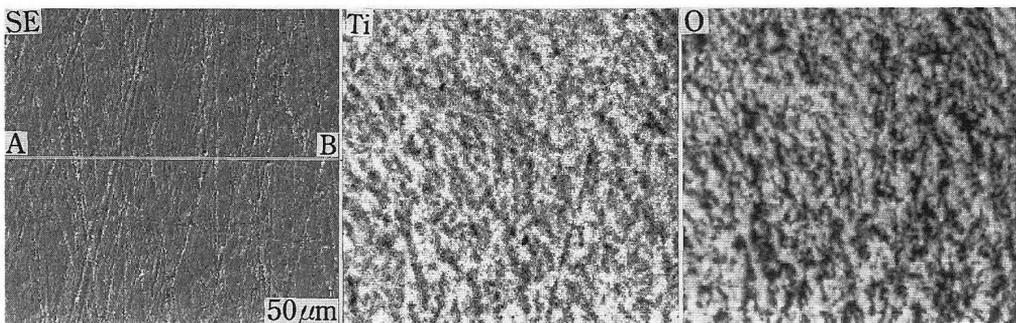
The element analysis of the interior far from the reaction zone was performed at a higher magnification. Fig. 2 shows an SE image and the corresponding maps of titanium and oxygen. Areas with low titanium contents and high oxygen contents were observed overall, providing dappled and reversely dappled patterns in these element maps. For a semi-

Fig. 2 Element distributions on an abraded Ti surface. Together with an 18-8 stainless steel chipping band, the specimen was resin-embedded and abraded to #1,000 grit.

quantitative evaluation, Fig. 3 shows line analysis profiles of titanium, silicon, oxygen, carbon, iron, chromium, and calcium along the line AB in the SE image of Fig. 2. From these profiles, it was found that the titanium content varied within about 10% of its maximum. The oxygen content, with a background of about 200 counts, varied remarkably in a range of about 200 to 1,000 counts, corresponding inversely to the distribution of titanium. In addition, iron and chromium were detected, nearly corresponding to the distribution of oxygen, though their contents were low. The iron was not an impurity included in the titanium, but a major component of the 18-8 stainless steel clipping band which was abraded together with the specimen; the distribution of iron corresponded closely to that of chromium. Nickel, which was not analyzed, could be detected together with the iron and the chromium. Calcium, which was distributed similarly to the other elements, originated from a filler component included in the embedding resin. We note here that silicon was detected not throughout but in a scattered distribution pattern in several isolated spots.

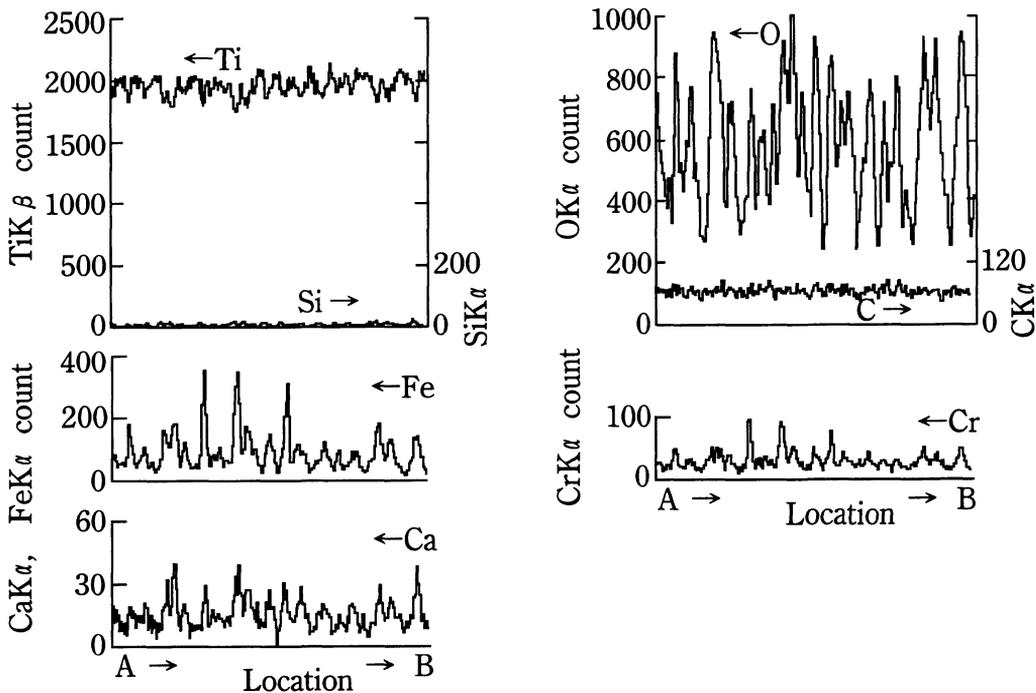
Fig. 3 Line analysis profiles of Ti, Si, O, C, Fe, Cr, and Ca along the line AB in the SE image of Fig. 2

the distribution of silicon corresponded closely to that of oxygen, entirely different from the result shown in Fig. 3. However, no peculiar aspect was found in the distribution of carbon. Although the specimen was carbon-evaporated, the contaminant carbon, if it existed, ought to be distinguishable from the evaporated carbon. In data not shown here, carbon was significantly detected together with silicon and oxygen on a surface abraded with silicone rubber polishers according to established dental techniques.

To test this hypothesis, another examination was performed using a type I dental casting gold alloy (55 to 90 Hv, ADAS #5). Fig. 6 shows the element distributions on the surface abraded to #600 grit. As described in Fig. 3, silicon was detected not overall but occasionally, suggesting the possibility that abrasive grits might be embedded in the gold alloy surface. Although the background of oxygen was rather high due to the existence of gold, the distribution of oxygen was obviously different from that shown in Figs. 1 to 4. This means that the contamination of titanium was related to its reactivity as well as its hardness.

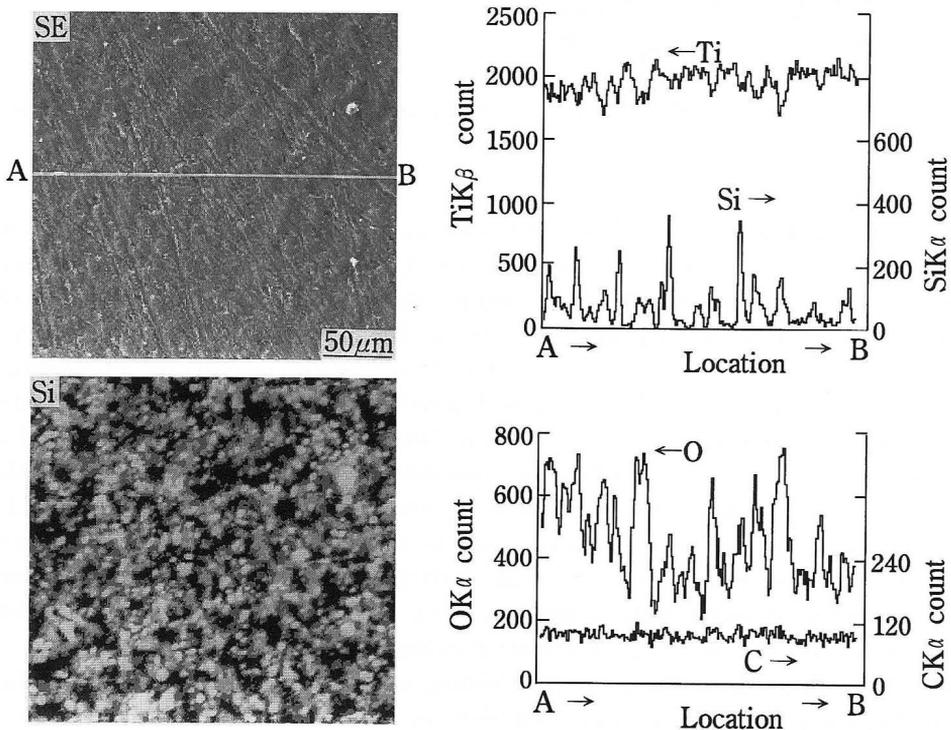
In order to escape the influence of the stainless steel band and the filler on the contamination, resin-attached specimens were abraded and analyzed. The hard reaction zone<sup>4)</sup> contaminated by the investment constituent elements was entirely removed by the abrading. Fig. 4 shows the results of the element analysis. The distributions of titanium and oxygen were qualitatively similar to those shown in Figs. 2 and 3. It is particularly noted here that

Fig. 4 Element distributions on an abraded Ti surface. The resin-attached specimen was abraded to #1,000 grit. The line analysis profiles show the distributions of Ti, Si, O, and C along the line AB.

In the SE image of Fig. 4, occasional patterns with dimensions of roughly 10 to 30  $\mu\text{m}$  were observed corresponding to the distribution of silicon or oxygen. In order to demonstrate these patterns more clearly, a specimen was set on the specimen stage at an angle of 60° to the electron beam and SE images were taken. Fig. 5 shows one of these images, in which contaminant deposits are observed overall.

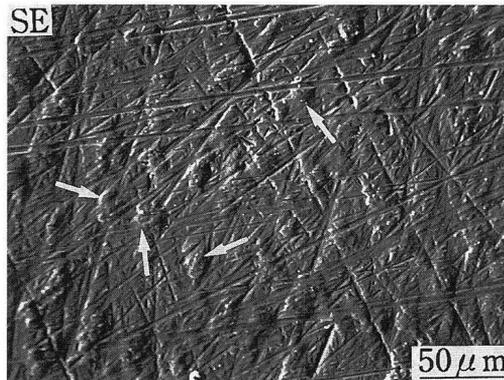
Fig. 5 An SE image showing contaminant deposits on an abraded Ti surface. Some deposits are indicated by arrows. The resin-attached specimen was abraded to #600 grit. To make the image, the specimen was set at an angle of 60° to the electron beam; the size scale is thus available only horizontally.

From the results shown in Figs. 1 to 5, it is obvious that all the abraded surfaces were contaminated by silicon and oxygen. Iron, chromium and calcium rather than silicon contaminated titanium when they existed together with the abrasive. The surface abraded to #600 grit was qualitatively the same as that abraded to #1,000 grit.

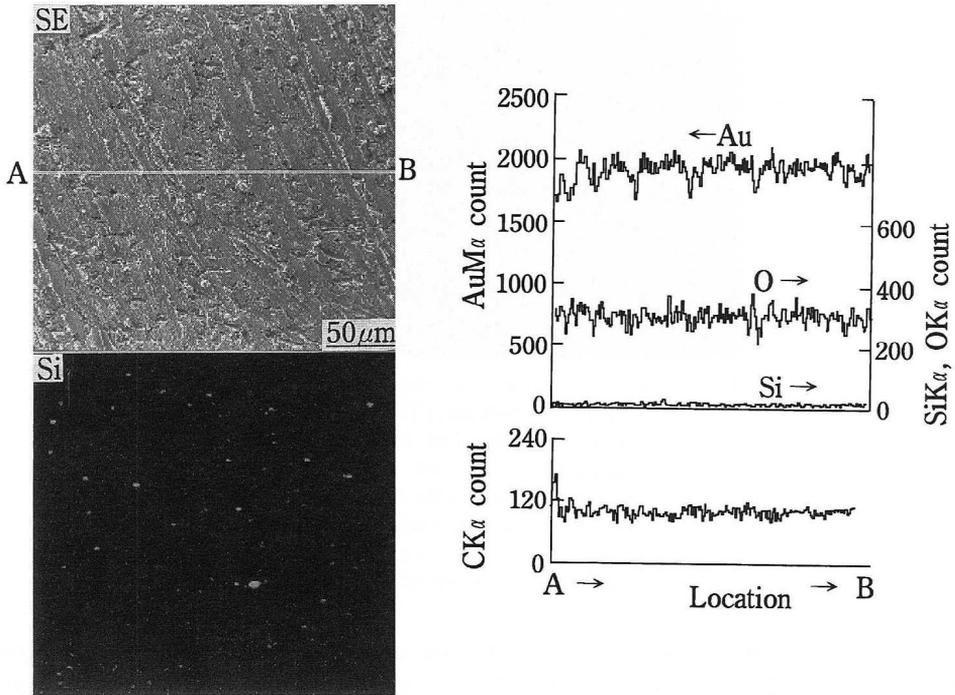
Fig. 6 Element distributions on an abraded type I gold alloy. The resin-embedded specimen was abraded to #600 grit. The line analysis profiles show the distributions of Au, O, Si, and C along the line AB.

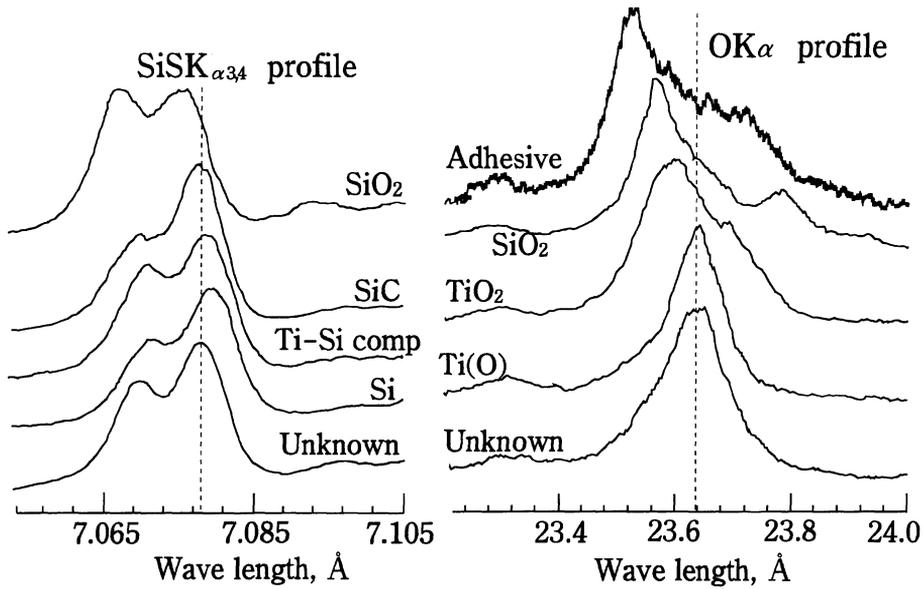
To determine the properties of the contaminant deposits, chemical bond state analysis was performed focusing on silicon and oxygen. The results shown in Fig. 7 indicate that the chemical bond state of the silicon was similar to that of silicon carbide or a titanium silicide<sup>4</sup>), neither silicon oxide nor silicon. The state of the oxygen was close to that of solute oxygen in titanium.

Fig. 7 Chemical bond states of Si and O on an abraded Ti surface. The profiles of Si satellite  $K_{\alpha 3,4}$  and O  $K_{\alpha}$  spectra of the contaminant were compared with those of standard substances. "Ti-Si comp" represents a net-shape and titanium silicide-like phase existing in the reaction zone of a titanium casting. "Ti(O)" is solute oxygen in the  $\alpha$ -case of a titanium casting.

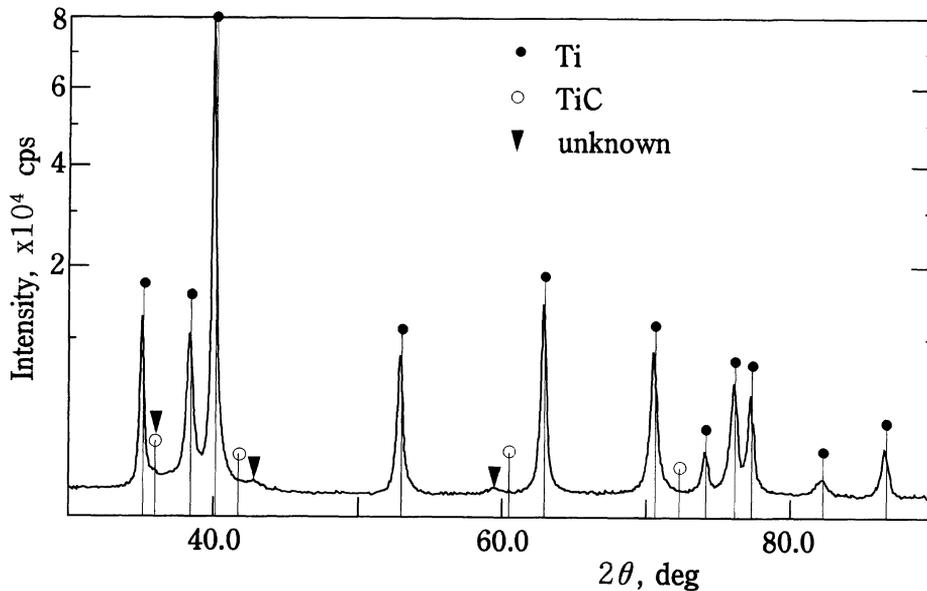
In order to identify the contaminant deposits, the abraded surface was analyzed by X-ray diffraction. Fig. 8 shows a chart of diffraction by the Bragg-Brentano method. In Table 1, peaks obtained in Fig. 8 were compared with standard peaks of the following substances:  $\alpha$ -titanium, titanium carbide, silicon carbide, silicon, graphite, and titanium silicides such as  $Ti_5Si_4$ ,  $Ti_5Si_3$ ,  $TiSi$  and  $TiSi_2$ . Except for three peaks of very slight intensity (arrow heads in Fig. 8), all the major peaks (solid circles in Fig. 8) were identified as  $\alpha$ -titanium with a confidence coefficient of 865, as shown in Table 1. However, the confidence coefficient for titanium carbide (open circles in Fig. 8) was 225 and those for the other substances were lower. In other words, the three unknown peaks could not be identified clearly, suggesting that the major portion of the contaminant deposit might be amorphous or very thin.

Fig. 8 An X-ray diffraction chart of an abraded Ti surface (Bragg-Brentano method). The resin-attached specimen was abraded to #1,000 grit. Refer to Table 1 for "Ti" and "TiC"

Peaks obtained in Fig. 8 were compared with those of the following possible substances;  $\alpha$ -Ti, TiC, SiC, Si, graphite, and titanium silicides such as  $Ti_5Si_4$ ,  $Ti_5Si_3$ , TiSi and  $TiSi_2$ .
